Checking of the cylinder head assy. (2/3) for ROTAX® Engine Type 912 and 914 (Series)

This ASB revises ASB-912-062/ASB-914-044 Revision 1

ATA System: 72-30-00 cylinder head

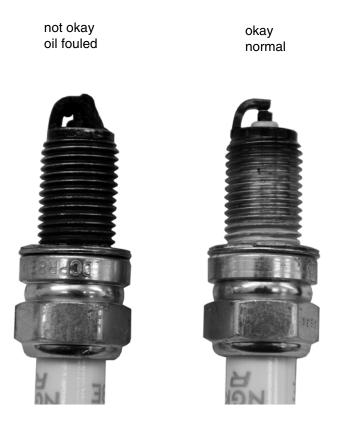
Fig. 1 spark plug

Due to a deviation in the manufacturing process some cylinder heads may have an oil leak in the intake channel in the area of the valve guide. There is a possibility of small machined through holes, which can increase the oil consumption which may result in an engine stoppage.

Unusual deposits (excessive carbon or oil) on the spark plugs are an indication of a defective cylinder head which must be replaced. Figure 1 shows comparison between a used spark plug in normal condition and one that is not.

Affected spark plugs with such deposits shown in chapter 4 Fig. 1, have to be removed and can not be reinstalled.

If excessive deposits (oil or carbon) are found on the spark plugs the cylinder head must be replaced in accordance with the relevant Maintenance Manual (Heavy) and any relevant aircraft manufacturer instructions.
