# ALERT SERVICE BULLETIN

## INSPECTION OF THE EXHAUST MUFFLER PART NO. 979402 FOR ROTAX® ENGINE TYPE 914 SERIES ASB-914-028R1

ASB-914-028R1  
page 1 of 4

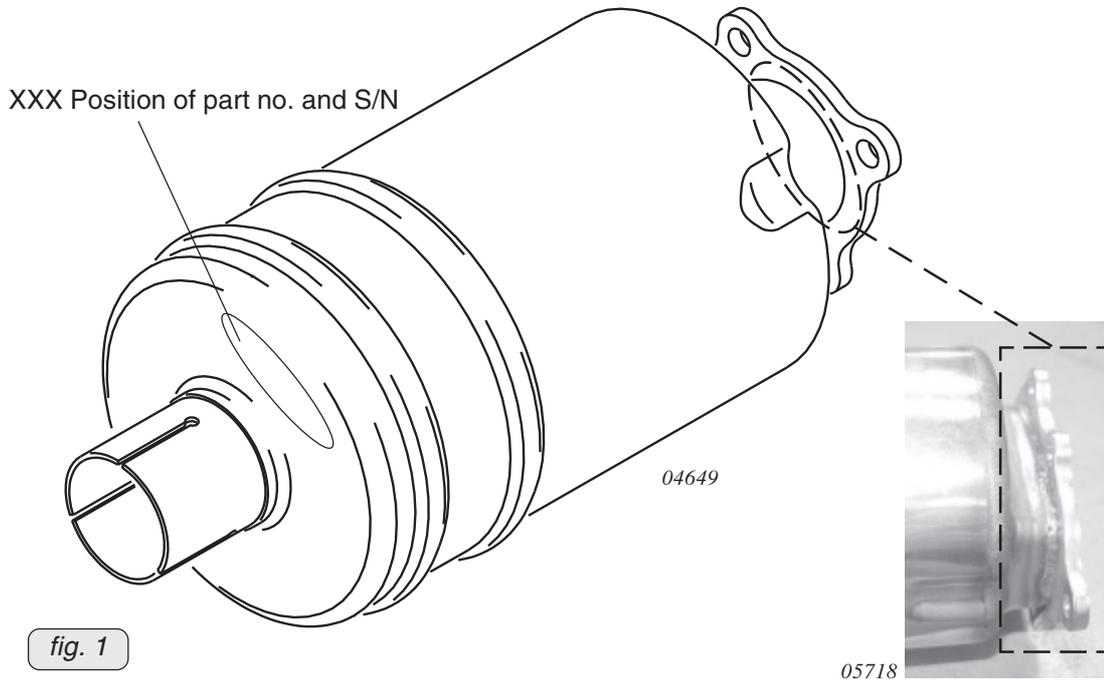
Cracks occurred on genuine ROTAX® exhaust muffler part no. 979402

◆ **NOTE:** Particular inspection in the area (exhaust flange) for exterior traces of smoke or existing cracks in the fillet (weld inlying) (as shown in fig. 1).

Inspect area for exterior traces of smoke and for cracks!

- If exterior traces of smoke or cracks are detected, do not operate the aircraft and immediately contact the nearest ROTAX<sup>®</sup> Authorized Distributor or their Service Centers for further action. (see also our official ROTAX-Web-Site: [www.rotax-aircraft-engines.com](http://www.rotax-aircraft-engines.com)).
