ALERT SERVICE BULLETIN

Exchange of exhaust valves on ROTAX® Engine Types 915 i A, 915 i B (Series) and 914 (Series)

ATA System: 72-00-00 Engine

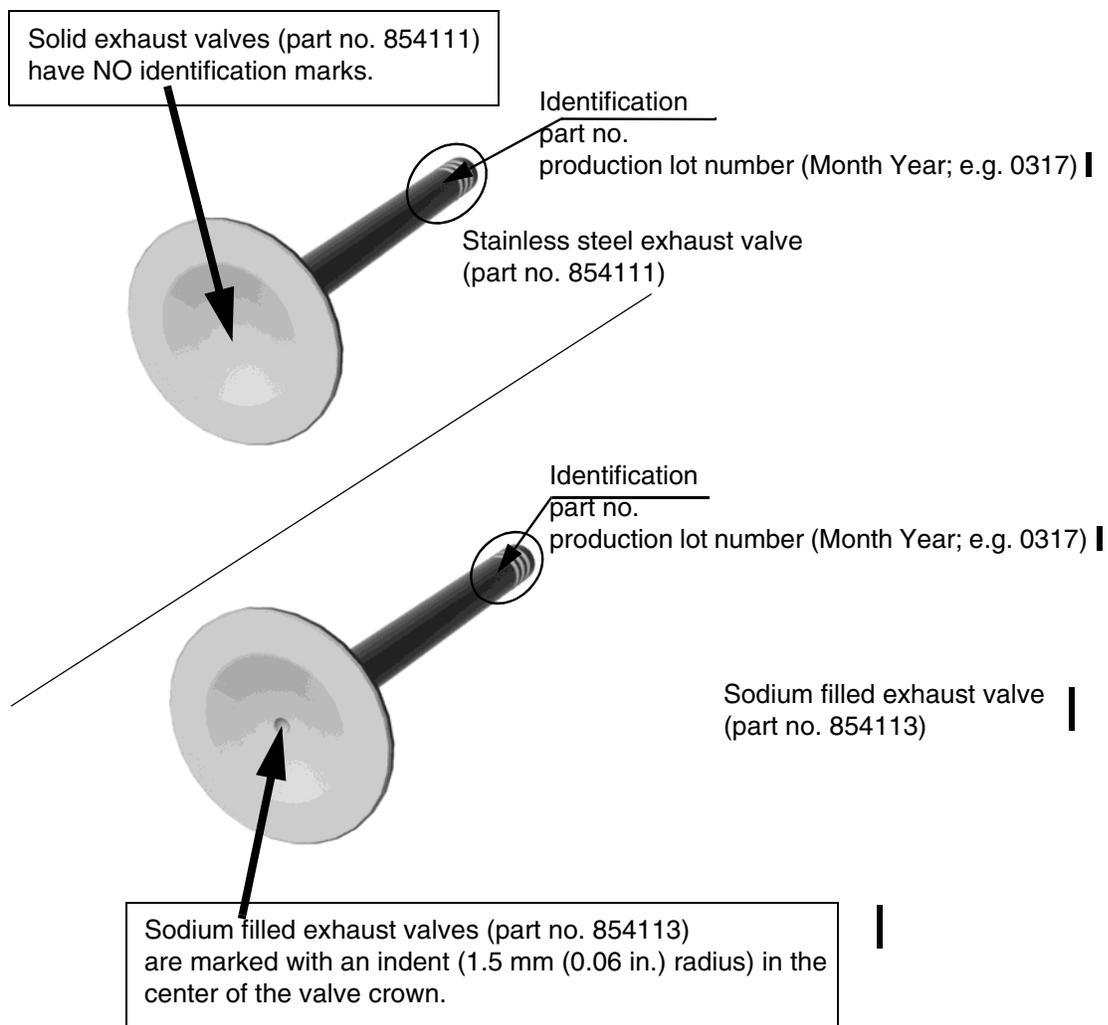
Fig. 2
Identification of exhaust valves

The engines below have been fitted by the manufacturer with an exhaust valve 32 mm (1.26 in.) part no. 854113 with a variety of production lots from which the production lot numbers 0317 and 0517 (see Fig. 2) are affected.

All engines are affected, which have been equipped with an exhaust valve 32 mm (1.26 in.) with part no. 854113 with a production lot number 0317 and 0517 during engine repair, maintenance or general overhaul (see Fig. 2).

Due to deviations in the manufacturing process of the exhaust valve 32 mm (1.26 in.) with part no. 854113 (for production lots affected see section 1.1) an exhaust valve cracking / fracture may occur. In consequence this may result in a malfunction of the valve train and a subsequent engine stoppage.

- All affected parts cannot further be used and must be marked unserviceable. These parts must be returned FCA (Free CArrier) to ROTAX[®] Authorized Distributors or their independent Service Centers
- Further sale, use or shipment of all affected exhaust valves part no. 854113 (see section 1.1) in stores (e.g. replacement parts) is not allowed and must be returned FCA to ROTAX[®] Authorized Distributors or their independent Service Centers
