SERVICE BULLETIN

MODIFICATIONS OF THE OVERFLOW BOTTLE FOR ROTAX® ENGINE TYPE 912 AND 914 (SERIES)

SB-912-039

SB-914-025

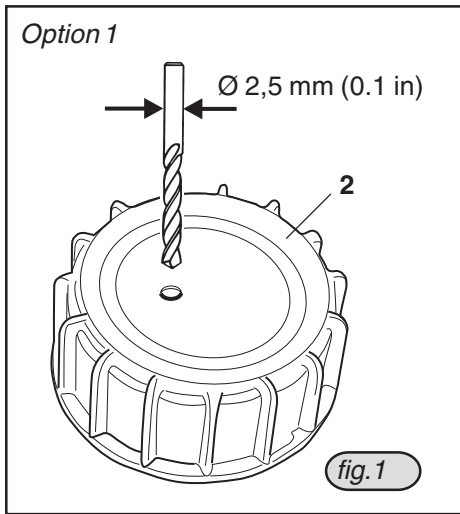
Field experience has shown that the coolant can start to boil due to one or several of the following causes.

This may lead to a pressure increase in the overflow bottle due to the high coolant temperature. This overload can create damages to the cooling system and as a result, damage the engine. Increasing the size of the vent hole in the plug screw of the overflow bottle can prevent such an increase.

(see fig. 1)

- Bore the existing vent hole from dia. 1mm (0.04 in.) to dia. 2.5mm (0.1 in.)
- Screw the cap onto the overflow bottle.
