ALERT SERVICE BULLETIN

Exchange of turbocharger/exhaust clamps on ROTAX® Engine Type 915 i (Series) and 916 i (Series)

ATA System: 78-10-00 Exhaust system

MANDATORY

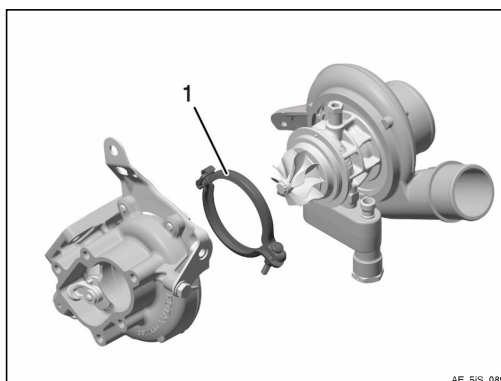
Fig. 1

1. Clamp assy.

Engine type 915 i (Series) and 916 i (Series)

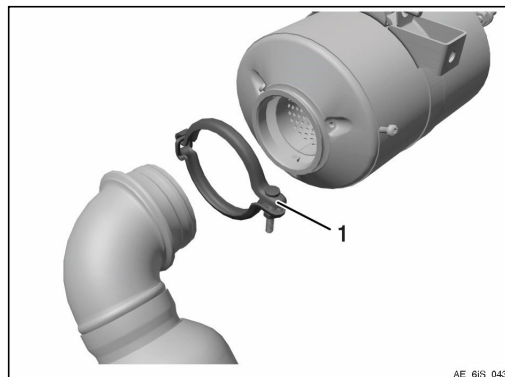
Fig. 2

1. Clamp assy.

Engine type 916 i (Series)

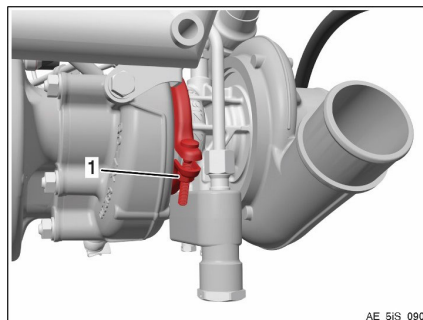
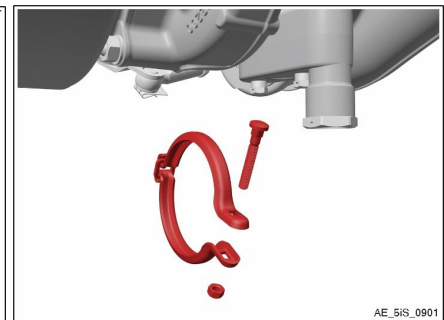
Fig. 3

Turbocharger clamp assy.

| Step | Procedure |
|---|---|
| 1 | Loosen Hex. nut M8 (1) from turbocharger clamp. NOTE: Support the turbocharger center housing and cold section. |
| 2 | Remove the clamp. |
