Inspection of crankcase halves for correct matching for ROTAX® 582 UL (Series)

ATA System: 72-20-00 Crankcase

MANDATORY

SERVICE BULLETIN

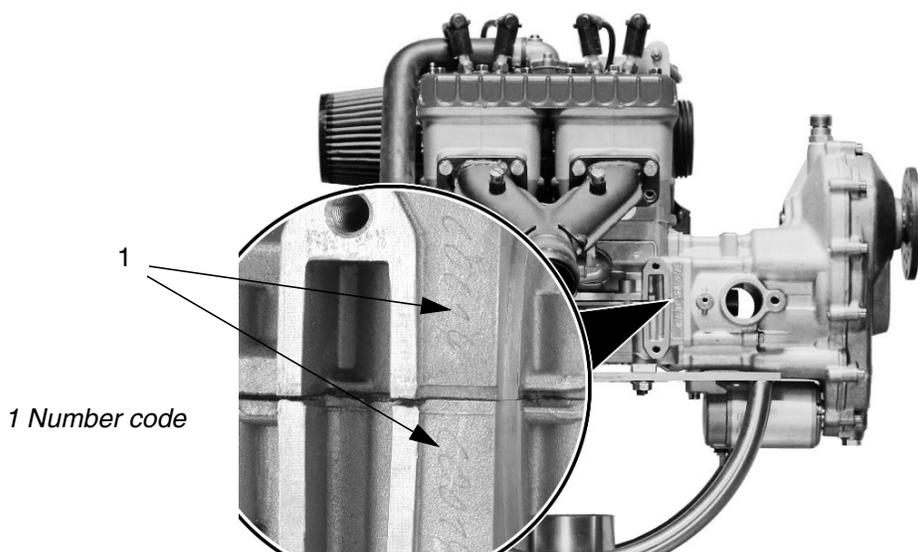
Fig. 1

Due to a deviation in the manufacturing process, a limited number of engines were assembled with non- matching crankcase halves.

Step	Procedure
1	Check the PTO end of the crankcase, water pump side. Here the crankcase is signed with a consecutive number code.
2	This number code must be the same on both crankcase halves.

Step	Procedure
3	If the numbers do not match, contact your local ROTAX® Authorized Distributors or their independent Service Centers for immediate engine replacement.
4	If the number code matches, no further work is necessary.
