AIRCRAFT ENGINES

SERVICE BULLETIN

NEW CHARGING COIL ASSY. WITH SUPPORT

SB-505-009 R1

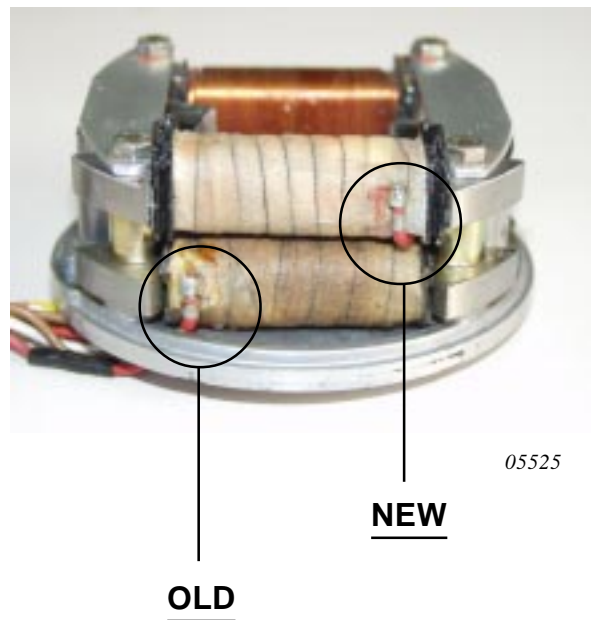
fig. 5

◆ NOTE: Because of changed wiring at the new type charging coil assy the charging cable soldering point is opposit on the right side (see fig. 5).

If an old type and a new type charging coil is fitted together as a working pair, the charging cable soldering point's are at the opposite side (see fig. 5).
