# SERVICE BULLETIN

## SPECIAL INSPECTION TO INCREASE THE TBO FOR ROTAX® ENGINE TYPE 912 (SERIES) SB-912-005UL

Special inspection to increase the TBO for ROTAX® Engine Type 912 (Series).

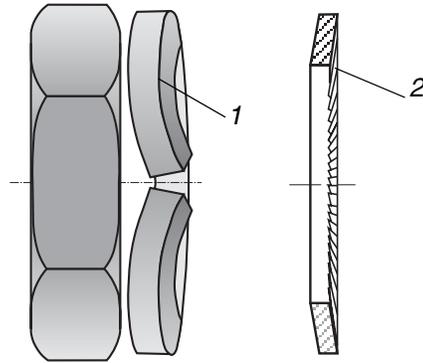
**Fig. 1**  
**Friction washer**

If hex. nut is still secured by a lock washer, it has to be exchanged for the friction washer (1) according to current Maintenance Manual (Heavy Maintenance).

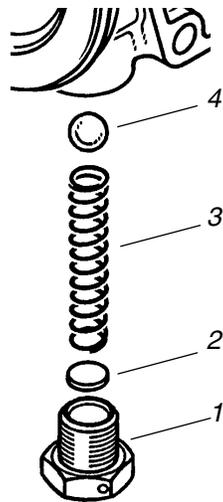
**Fig. 2**  
**Improved oil pressure control**

From engine S/N 4,005.186 onwards, to improve oil pressure control the following parameters of the relief valve were changed. Free length of the compression spring (3) was reduced from 46 mm (1.81 in.) to 39 mm (1.55 in.). Spring rate was changed by increase of wire dia. from 0,8 mm (.031 in.) to 0,9 mm (.035 in.), and dia. of ball was increased from 8 mm (.31 in.) to 8,5 mm (.33 in.). If existing, remove shim (4), but if specified oil pressure can't be reached, adjust pressure by adding shim again.

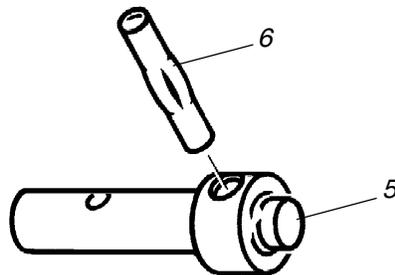
**Fig. 3**  
**Oil pump shaft**

From engine S/N 4,152.101 onward the follower in the oil pump shaft (6) was changed to notched pin (5) instead of the former dowel tube.

At a renewal of components change oil pump to the version with the 16 mm (.63 in.) long rotors.

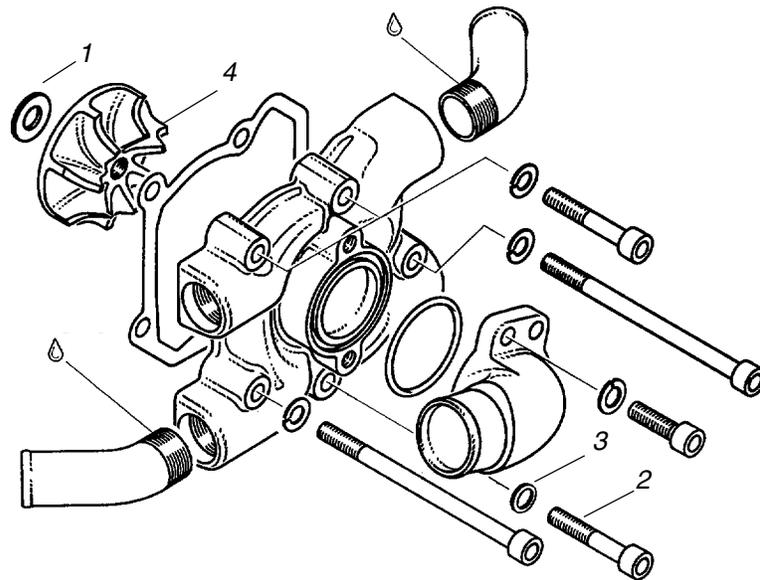
**Fig. 4**  
**Water pump**

Operation of the engine without antifreeze in the coolant is not permitted since increased formation of corrosion. Therefore the material of the pump shaft was changed with engine S/N 4,152.414. Because of galvanic reactions, caused by the use of various materials, the washer (1) and the screw (2) are of stainless steel since engine S/N 4,152.607.

Remove, checking and installation in according to current Maintenance Manual (Heavy Maintenance).

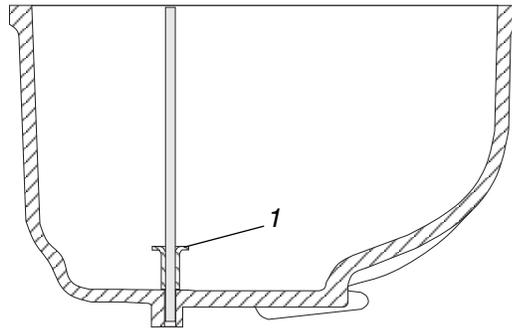
**Fig. 5**  
**Check of float chamber**

Remove float chamber and lift out both floats. If float chamber is still without distance pieces (1), part no. 861920, add them now, thus avoiding possible sticking of the floats in the float chamber.

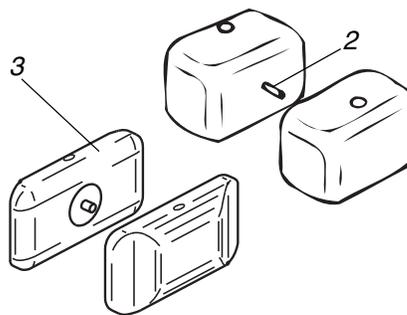
**Fig. 6**  
**Check of float**

Check support pin (2) of floats. At heavy wear of float bracket contact faces, caused by excessive vibration, exchange these floats to floats of modified shape and renew float bracket as required.
