SERVICE BULLETIN

SPECIAL INSPECTION TO INCREASE THE TBO FOR ROTAX® ENGINE TYPE 912 A (SERIES) SB-912-005 R3

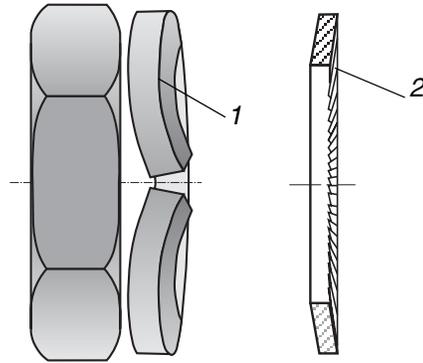
Fig. 1
Friction washer

- 1 lock washer
- 2 friction washer

If hex. nut is still secured by a lock washer, it has to be exchanged for the friction washer (1) according to current Maintenance Manual (Heavy Maintenance).

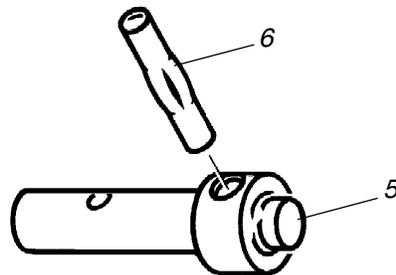
Fig. 3
Oil pump shaft

From engine S/N 4,076.068 onward the follower in the oil pump shaft (6) was changed to notched pin (5) instead of the former dowel tube.

- 5 oil pump shaft
- 6 notched pin

At a renewal of components change oil pump to the version with the 16 mm (.63 in.) long rotors.

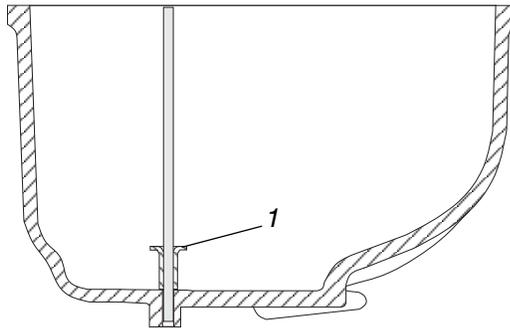
Fig. 5
Check of float chamber

- 1 distance pieces

Remove float chamber and lift out both floats. If float chamber is still without distance pieces (1), part no. 861920, add them now, thus avoiding possible sticking of the floats in the float chamber.
