SERVICE BULLETIN

Periodic checking of the crankshaft journal (power take off side) for ROTAX® Engine Type 912 and 914 (Series)

ATA System: 72-20-00 Engine block

MANDATORY

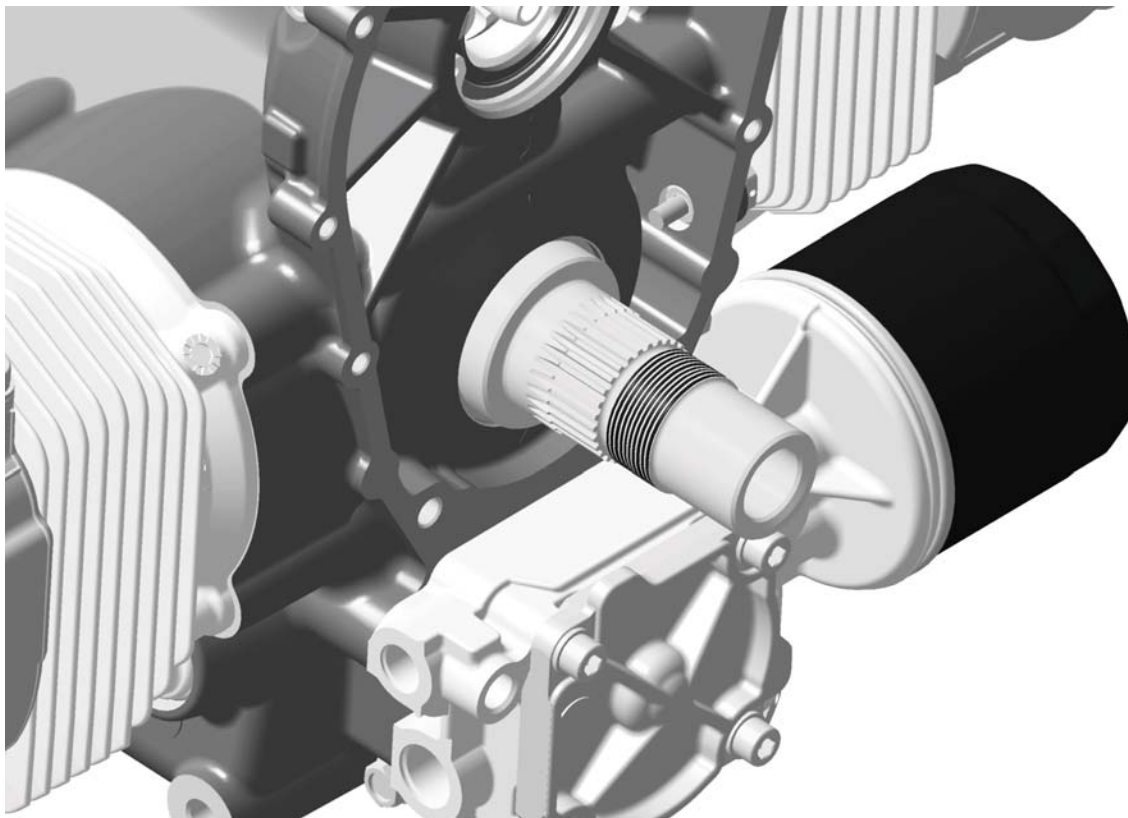
Fig. 1
Crankshaft journal

Due to a deviation in the manufacturing process some crankshafts may develop a crack on the power take off side. These cracks can cause breakage of the crankshaft in the support bearing during operation. In this case the function of the support bearings (consisting of 3 main bearings and 2 support bearings) is compromised. The operating reliability, however, is given until the next maintenance.

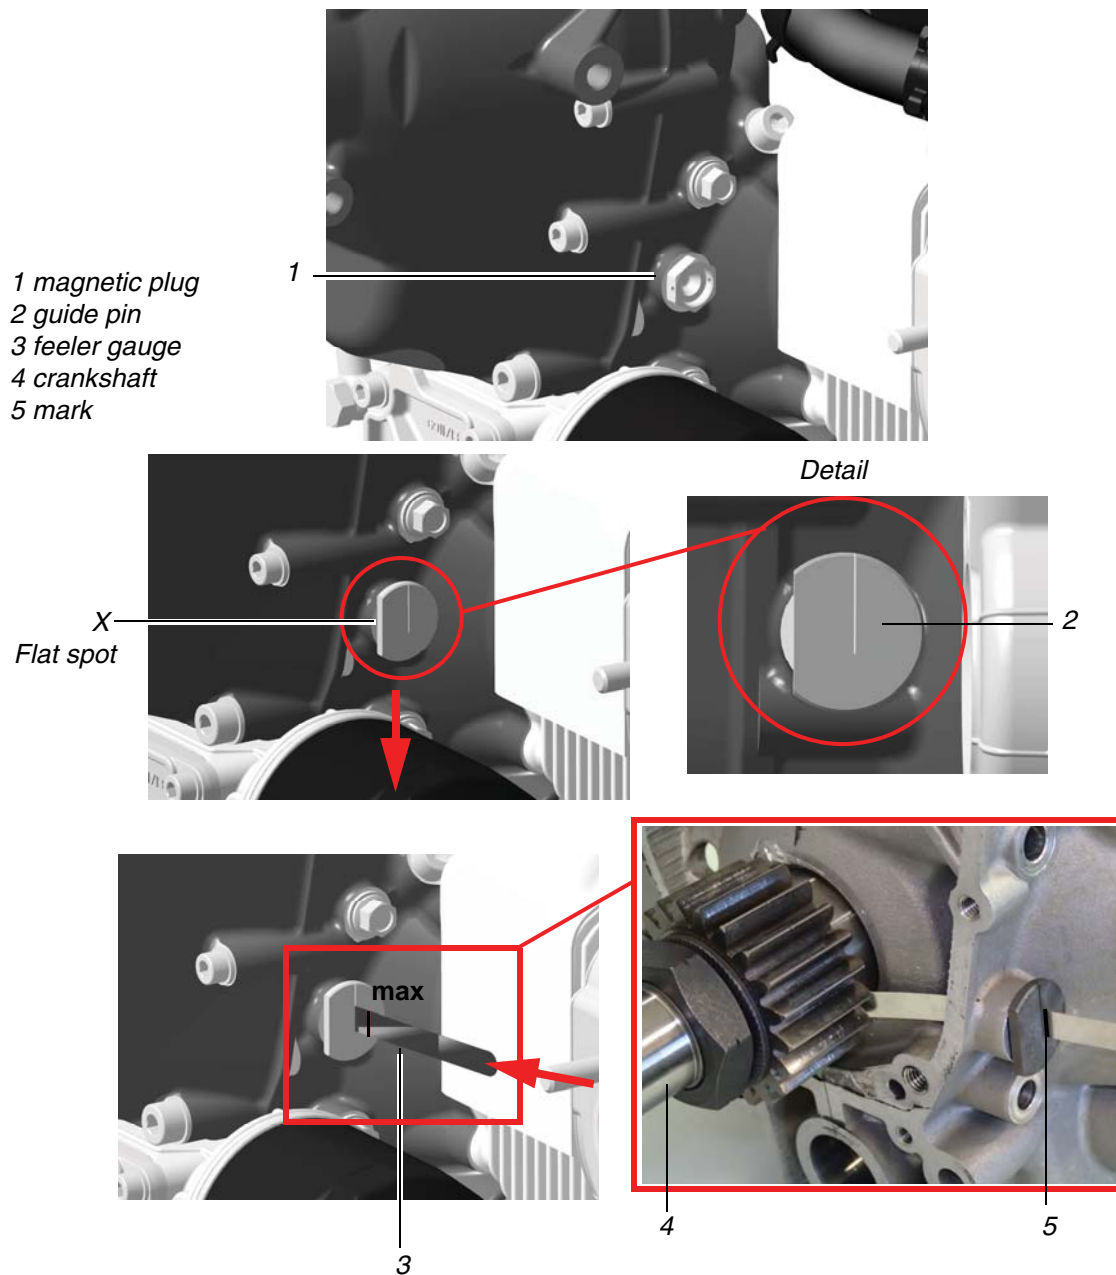
Fig. 2
Inspection with feeler gauge

| Step | Procedure |
|---|---|
| 2 | Install guide pin (2) of the check gauge CS-PTO into the magnetic plug thread until stop. Adjust the guide pin with the flat spot (X) in the direction of the propeller and parallel to the gearbox/housing contact surfaces. Hold it in fixed position not allowing any rotation. Pliers or an open-end spanner can be used. |
| 3 | Insert feeler gauge of check gauge CS-PTO into the guide pin. NOTE: The feeler gauge is symmetrical, both sides can be used. |

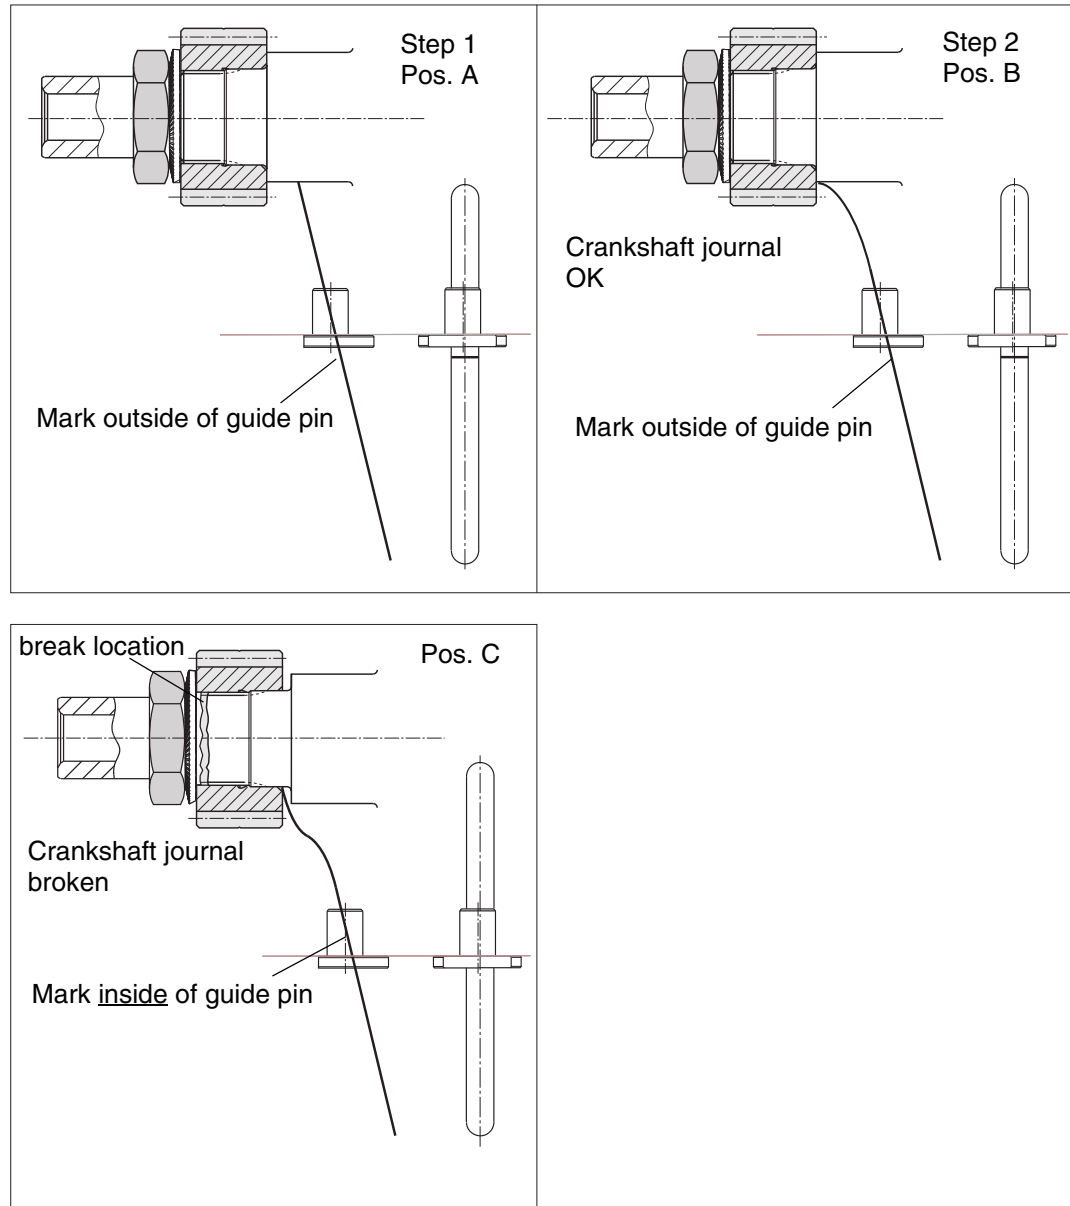
Fig. 3

| Step | Procedure |
|---|---|
| 4 | Insert feeler gauge until a first resistance can be felt. Now the feeler gauge faces the cylindrical crankshaft journal (see Fig. 3, Step. 1). |
| 5 | With slightly elevated force you can push the feeler gauge about 2 mm (.078 in.) further in, until it touches the plan surface of the pinion gear (see Fig. 3, Step. 2). NOTE: The mark on the feeler gauge is still visible outside the slot. |

| Step | Procedure |
|---|---|
| 6 | Hold it in fixed position not allowing any rotation. If the feeler gauge can be pushed further in, so that the mark disappears in the slot, then the gearbox must be removed and the crankshaft must be checked (see Fig. 3, Pos. C). |

The replacement of the crankshaft is only necessary, if inspection result 2 is applicable.

- In case of a broken crankshaft journal or any doubt contact your aircraft manufacturer and your nearest authorized ROTAX® aircraft engine distributor.
