## ROTAX 582 UL DCDI — marking of pick-up

This Service Information concerns all ROTAX engines 582 UL DCDI beginning with engine no. 4,084.219.

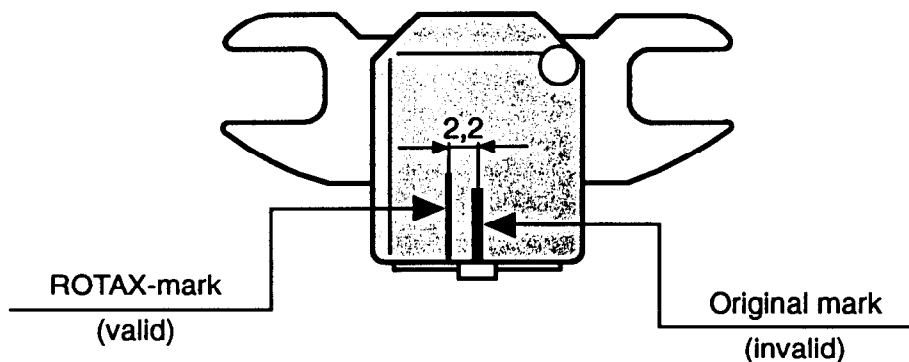
Because of the incorrect marking by our supplier all the pick-ups (part-no. 965 760 and 965 767) had to be marked supplementary.

This mark is placed 2,2 mm beside the erroneous original marking (see sketch).

At an ignition timing check the supplementary mark of the pick-up has to be in line with the mark on the flywheel.

◆ NOTE: Pick-ups have to be fitted with a gap of  $0,5 \text{ mm} \pm 0,05 \text{ mm}$  to the trigger bar on flywheel.
