Tapped hole for M8 cylinder stud in crankcase on ROTAX engines type 912 UL and 912 A, certified to JAR 22

Checking of the tapped hole ❶ in crankcase at cylinder no. 2.

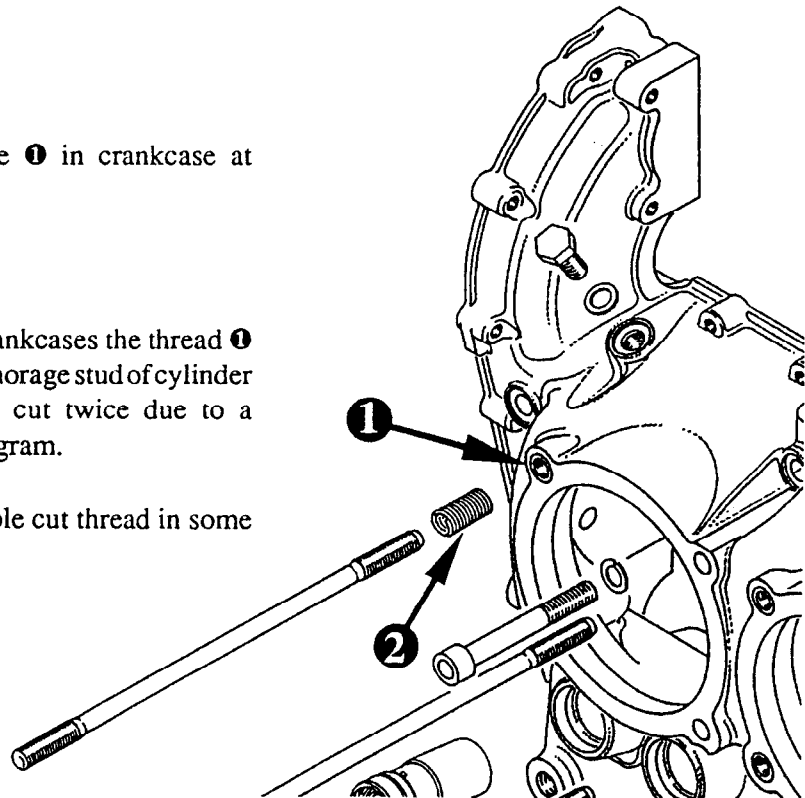
It was noticed that in some crankcases the thread ❶ for the helicoil insert ❷ for anchorage stud of cylinder and cylinder head had been cut twice due to a mistake in the machining program.

The result thereby was a double cut thread in some cases.

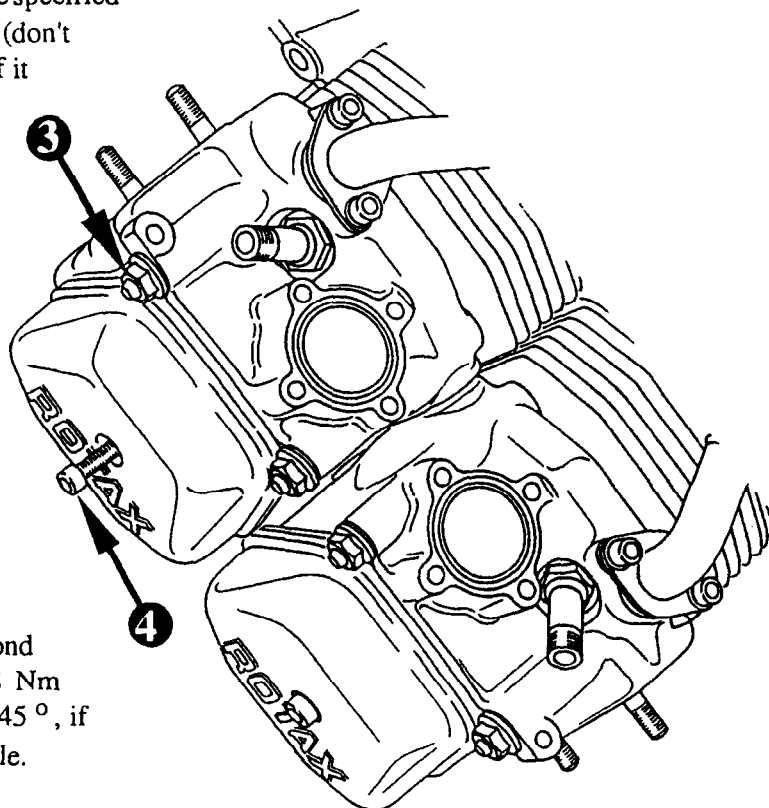
On an engine installed in an aircraft with at least three hours operating time tighten the hex. nut M8 ③ on cylinder 2 to the specified torque of 18 Nm = 160 in.lb. (don't loosen before tightening). If it needs 45 ° or more wrench movement for tightening the thread must be rectified.

If on the first check the needed turn was less than 45 ° a second check for safety shall be carried out after further 3 hours running time. The thread is o.k. if at the second check the tightening to 18 Nm (160 in.lb.) takes less than 45 °, if more, rework the tapped hole.
