**ROTAX****S E R V I C E I N F O R M A T I O N**

7 UL 97-D/E

Kalibrierung der Gemischanreicherndüse bei Rotax 914 UL (Serie)**Calibration of the mixture enrichment jet of ROTAX 914 UL (series)****Vorgeschrieben / mandatory****1) Wiederkehrende Symbole:**

Verification or calibration of the mixture enrichment jet.

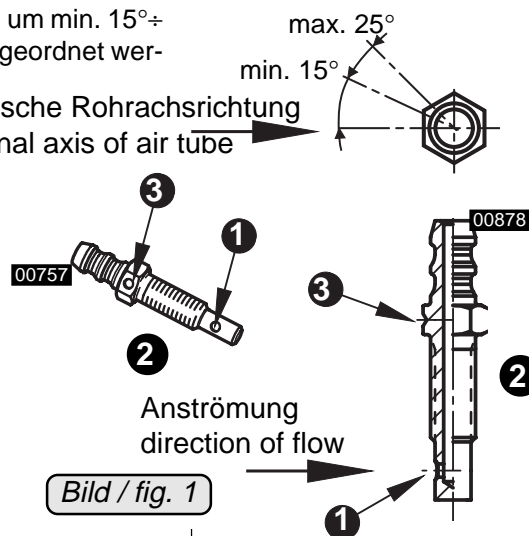
geometrische Rohrachsrichtung
longitudinal axis of air tube

On the engines affected the pressure control bore of the mixture enrichment jet might be badly positioned, resulting in a too lean mixture at take-off performance.

The pressure control bore ① in the mixture enrichment jet ② has to be positioned min. 15° to max. 25° deviating to the theoretical flow direction.

◆ **NOTE:** This becomes necessary as the turbo charger causes a twist of the air flow which would result in an unfavourable angle of attack on the pressure control bore, if the mixture enrichment jet is installed straight.

The position of the pressure control bore is indicated clearly by the counter sinking ③ on the hexagon. See fig. 1 and 2.

With the longitudinal axis of the intake tube as reference, mark the tube at an angle of 15° to 25° in clockwise direction.
