**ROTAX.** SERVICE INFORMATION

8 UL 94-E

#### May 1994

#### ATTACHING OF WATER PUMP HOUSING ON ROTAX 582 UL DCDI

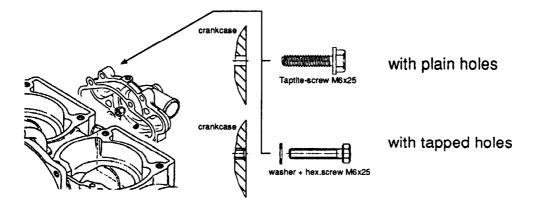
■ ATTENTION: At receipt of one of the assemblies stated above, please, check if the holes in the top crankcase half assigned for water pump attachment are tapped or just plain holes.

Basically the attachment is as follows:

Is with plain holes the attachment is with the 4 TAPTITE screws M6x25 (part no. 841 540), secured with LOCTITE 221 and tightened to 8 Nm (70 in.lb.)

⇒ with holes tapped, the water pump housing is attached with 4 hex. hd. screws M6x25 (part no. 244 211), secured with LOCTITE 221 and tightened to 8 Nm (70 in.lb.)

At a repair, check first which screws are fitted and at renewal of these screws, use same type as used before.
