SERVICE INSTRUCTION

AMENDMENT ON REDUCTION GEARBOX

TYPE „C“ AND TYPE “E“

SI-2ST-007 R2

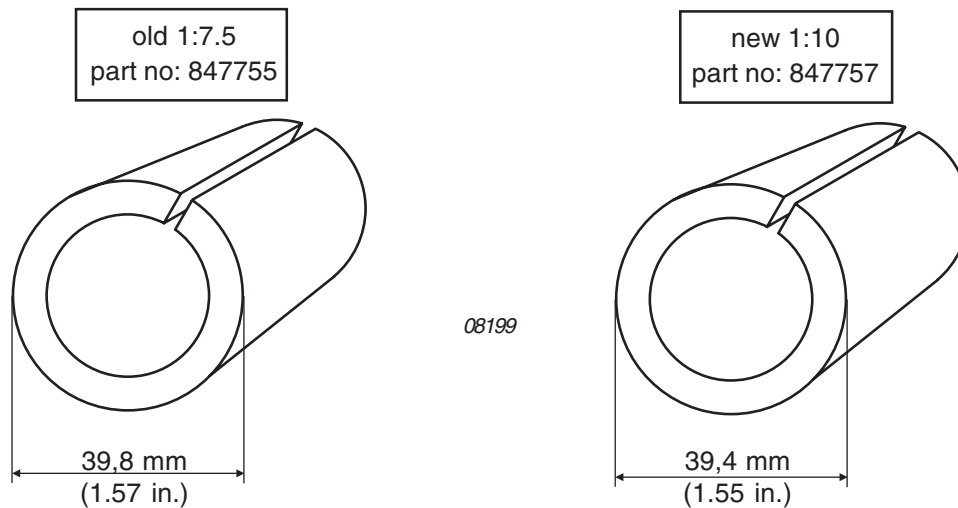
2.3) For distinguishing the cone sleeve

The cone sleeves can be distinguished according to following drawings. To prevent measurement mistakes the diameter has to be determined as follows:

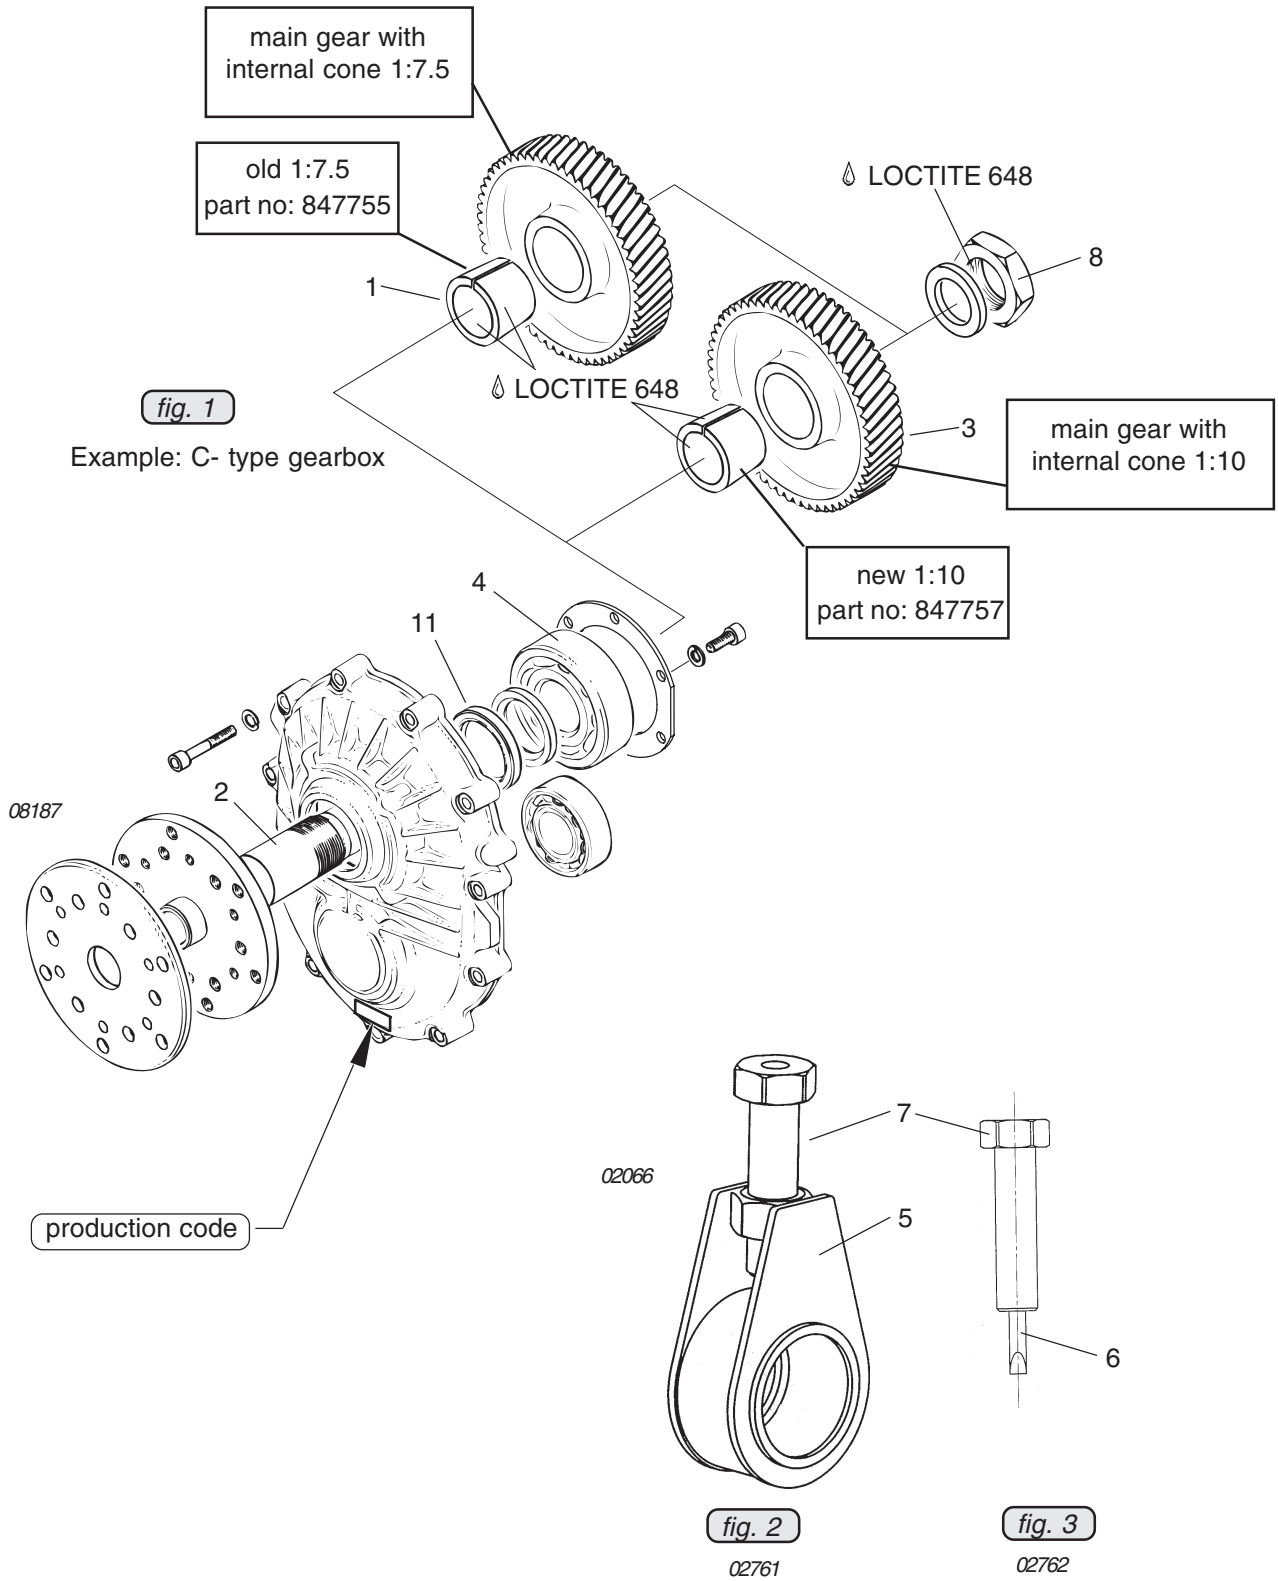
▲ **WARNING: Use of the new cone sleeve in combination with the old style main gear set and vice versa can lead to engine and personal injury!**

3. Apply LOCTITE 648 on inside of cone sleeve (see fig. 1).

■ CAUTION: Use correct gear set to the respective cone sleeve variants (see section. 2.3).

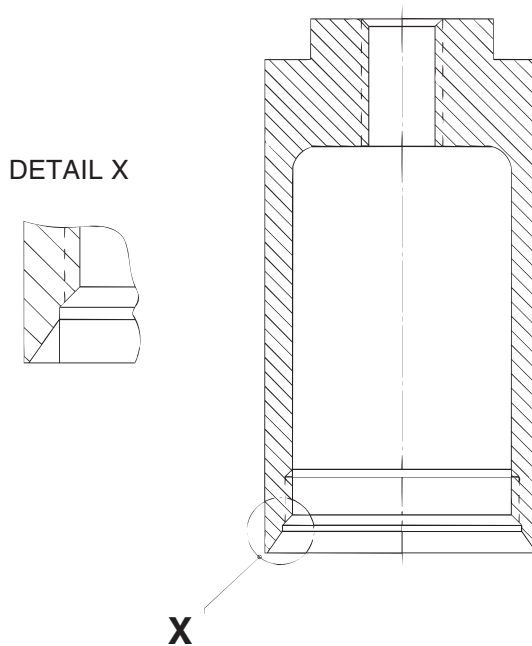
fig. 5
04792

puller assy for lay shaft gear

- ▲ WARNING: Risk of scalds and burns! Observe the appropriate safety precautions.
4. Fit the puller assy. (9) part no. 877379 on layshaft gear and tighten with wrench 36 A/F.

5. Screw-in and tighten the puller screw. If necessary separate the layshaft gear by a blow of the hammer on the tightened puller screw.
 - CAUTION: Use a suitable mat for not damaging the removed parts.
