# SERVICE INSTRUCTION

## FUEL PRESSURE INDICATION PROBLEMS

### ON ROTAX® ENGINE TYPE 912 (SERIES)

#### SI-912-008

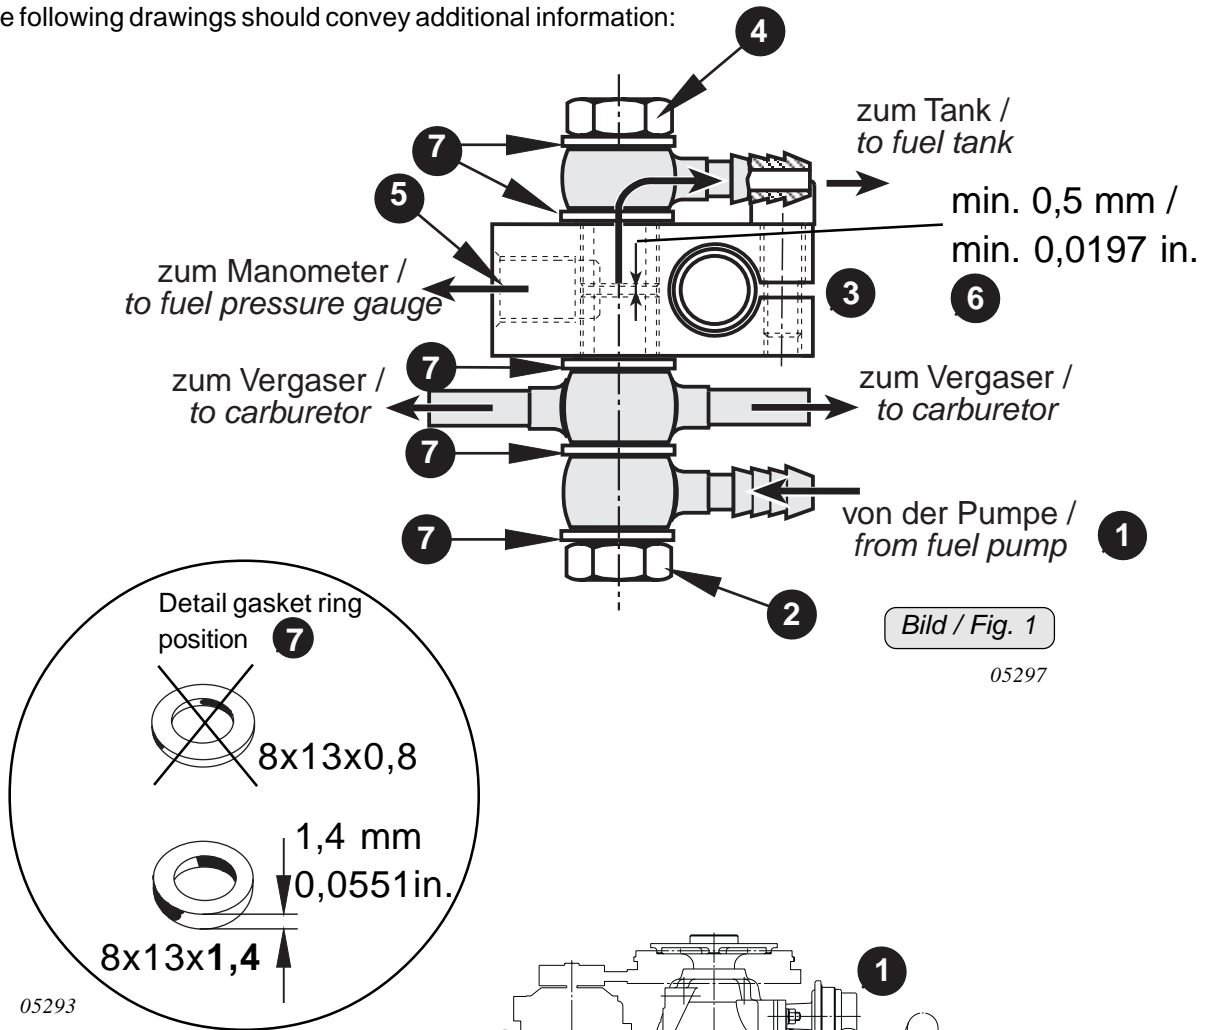
Bild / Fig. 1

Reduced tolerances between Banjo Bolts P/N 940872 and 941780 at clamp block P/N 851325 could result in intermittent or complete failure of the customer installed fuel pressure indication system.

- over torquing of Banjo Bolts
- installation of stretched Banjo Bolts
- installation of used gasket rings
- crushed hose nipples
- any combination of the above

The fuel passes from the fuel pump (1) via the banjo bolt (2 & 4) to the carburetors. Fuel is allowed to enter the clamp block (3) through the gap (6) present between the two banjo bolts and pressurize the outlet port (5) for delivery to a customer supplied fuel pressure indication system. Reduced tolerances of the assembled components could result in the gap (6) becoming closed or too small to allow fuel pressure into the manifold block at port (5). This could result in intermittent or complete malfunction of the customer installed fuel pressure indication system.

By virtue of design, fuel would continue to pass from one banjo bolt (2) to the other banjo bolt (4) thereby having no affect on the supply of fuel to the carburetors.

In all cases a gap (6) of at least 0,5 mm (0,0197 in.) must remain between the banjo bolts.

|| If inspection of the components to ensure conditions listed in section 1.3 do not exist and the gap is still below the minimum so all gasket rings (8/13/0,8) are to be renewed by the gasket rings PNo. 950143 (8,2/13/1,4).
