SERVICE INSTRUCTION

Introduction of a new clamp part no. 638140 for ROTAX 912 i Series

ATA System: 76-00-00 Engine control

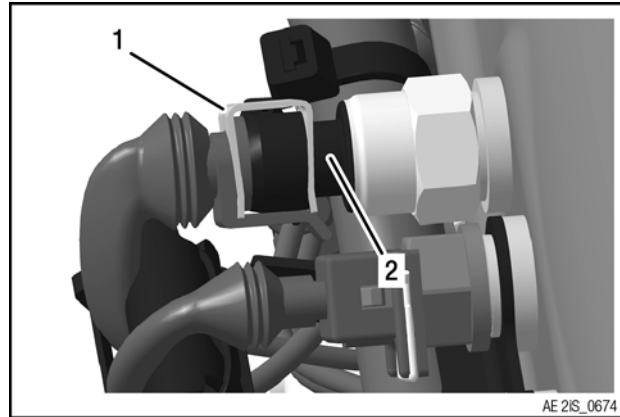
Fig. 1

In the course of continuous development an additional clamp part no. 638140 has been introduced, which improves the connection and tight fit of the MAP sensors.

POSITION OF THE CLAMP

Step	Procedure
1	Check connector of MAP sensors for tight fit. NOTE: Make sure the connector latch shows vertically to the bottom.
2	Install the clamp as shown in figure 1. Check for tight fit and correct position of the clamp on sensor and connector. NOTE: To remove the clamp use a proper pair of pliers.
