Information on fuse box assy. modifications for ROTAX_® Engine Type 912 i (Series)

ATA System: 76-10-00 Fuse box

SERVICE INSTRUCTION

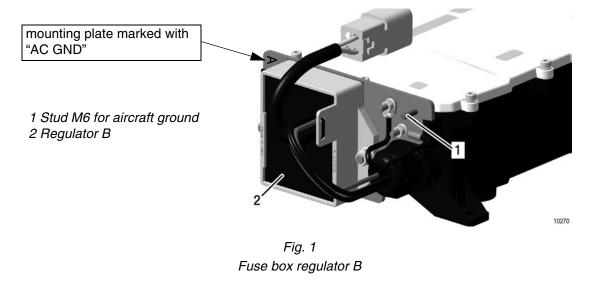
In the course of further development and standardization a new fuse box has been introduced. The new fuse box incorporates larger diameter grounding studs on the regulator B mounting plate (AC GND). Grounding studs have been increased in size from M4 x 1 to M6 x 1.

When retrofitting the new style fuse box assy. (part no. 881321) to an older engine, the connection to the aircraft harness must have its ground connectors replaced e.g. with larger M6 (1/4 inch) ring terminal and needs to be installed with e.g. washer and appropriate lock nut. See Fig. 1.
