SERVICE INSTRUCTION

ENGINE START AT LOW TEMPERATURES AT ROTAX® ENGINE TYPE 912 AND 914 (SERIES) SI-03-1998 R1

Engine start at low temperatures at ROTAX[®] Engine Type 912 (SerieS) And 914 (Serie)

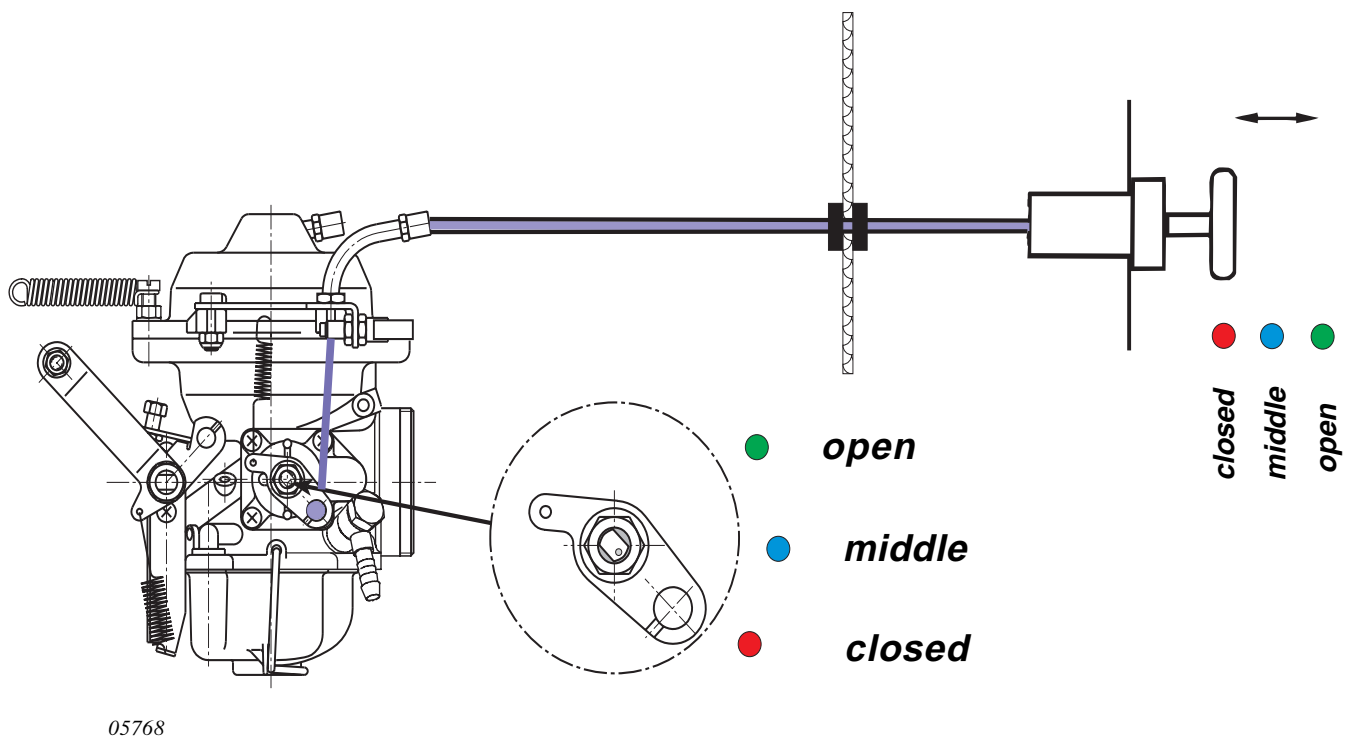
fig. 1

When using a larger start jet (1), the new choke rotary disc valve (2) with changed ventilation bores (5) must also be used. This makes it possible to operate the engine at a middle setting of the cold-start system during the warm-up phase and thus get a smooth engine operation (start of serial production, see chapter 2.3).

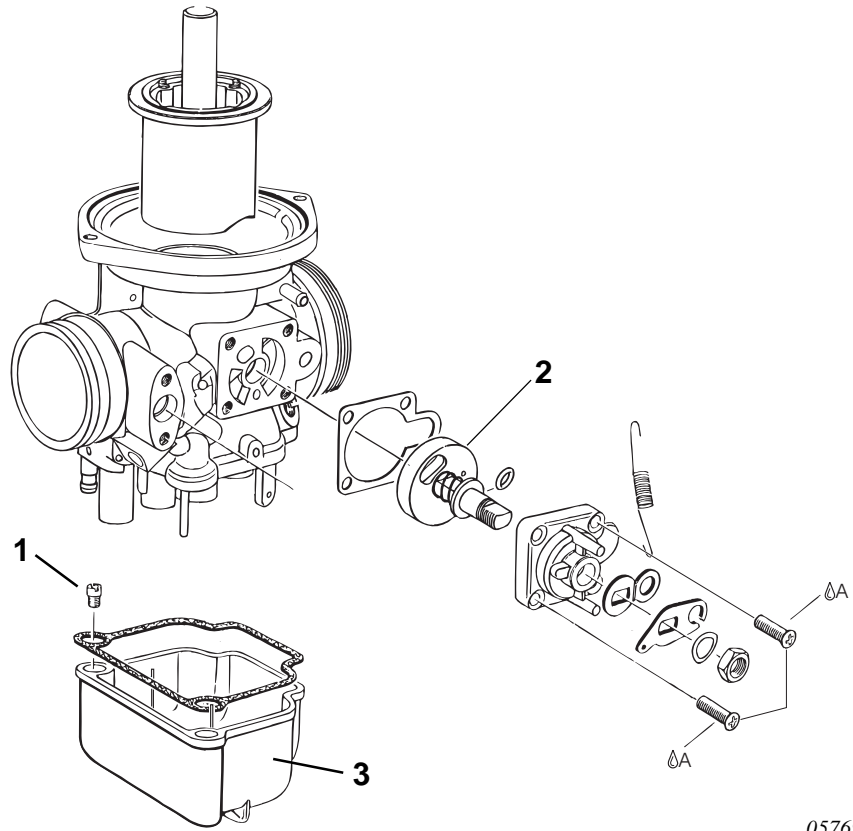
fig. 2

For engine start at low temperatures a different start jet and modified choke rotary disc valve (2) is recommended on both carburetors. Therefore the fuel-air mixture is highly enriched at the starting phase and throttled down by the additional middle setting at the warm up phase to get smooth engine operation.

The start jet (1) (jet 85 standard jet system) in the float chamber (3) must be exchanged for an applicable larger jet (1). Jets of the following sizes can be selected depending on the usual atmospheric conditions and the cold start behaviour of the engine:

Jet 105, 120, 130 or 140 (see chapter 2.4).

◆ NOTE: The jets (1) are selected by trial and error, but it must be noted that the fuel-air mixture can be highly enriched and can lead to a fuel over-enrichment in very bad cases.
