**Ignition unit of ROTAX engine 912 A**

Revision 1

**Airworthiness Directive
No. 75**

Subject: Ignition for Rotax 912 A Series, all engines up to S/N 4,076.022

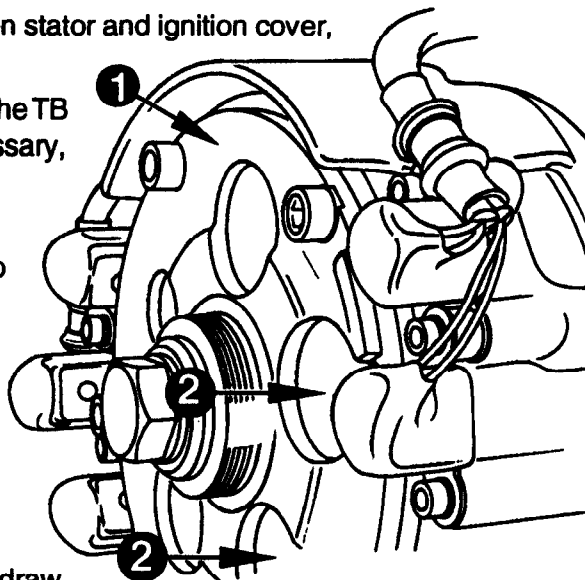
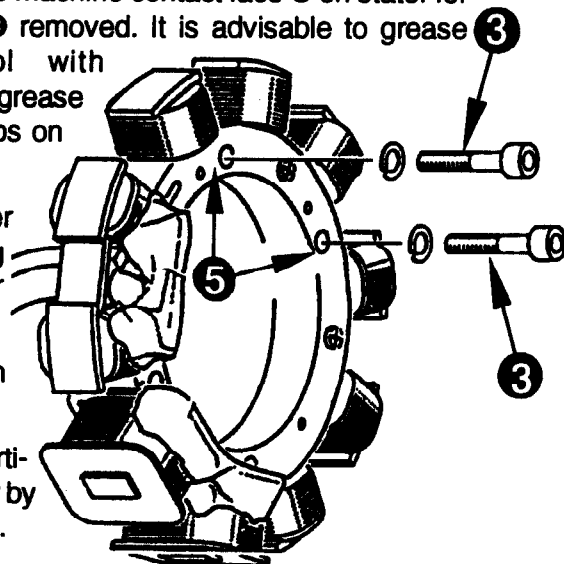
Subject: As known from experience, inadequate ground connection could arise between stator and ignition housing on the engine type 912 A.

Reason: Isolated formation of corrosion between stator and ignition cover, respectively at attachment screws.

Reason: Corrosion between stator and igniter housing causes insufficient ground connection which may result in ignition troubles.

Description: Ensure proper contact between attachment screws and stator by the removal of insulation layers. This can be carried out with engine installed in the aircraft.

Disconnect battery. No need to withdraw magneto housing ❶ with magneto ring. Remove at least 2 of the 4 Allen screws ❸ and lock washers for stator attachment via the openings ❷ in the magneto housing.

■ **ATTENTION:** Make absolutely sure that no foreign matter (lock washer or screws) will stick to the magneto ring.

Use spot-facing cutter ❹ or similar tool to machine contact face ❺ on stator for the screws ❸ removed. It is advisable to grease cutting tool with Lithium-base grease to collect chips on cutter and not on magneto ring.

Refit screws M5 along with lock washer and tighten to 6 Nm. To ensure lasting ground connection, treat contact faces for screws with Lithium-base grease.

Reconnect battery and carry out ignition check.
