**Ground connection for pick-up wiring, Rotax Engine Series Type 912****Mandatory**

- Subject:** improvement of ground connection for the screening braid of pick-up wiring and charging cable
- Engines affected:** All engines of Series 912 A, beginning with engine no. **4,076.064**, since introduction of the SMD-ignition unit.

AIRWORTHINESS DIRECTIVE

Subject: **SMD-Ignition for Rotax 912 A Series, Engines beginning with S/N 4,076.064 and subsequent_**

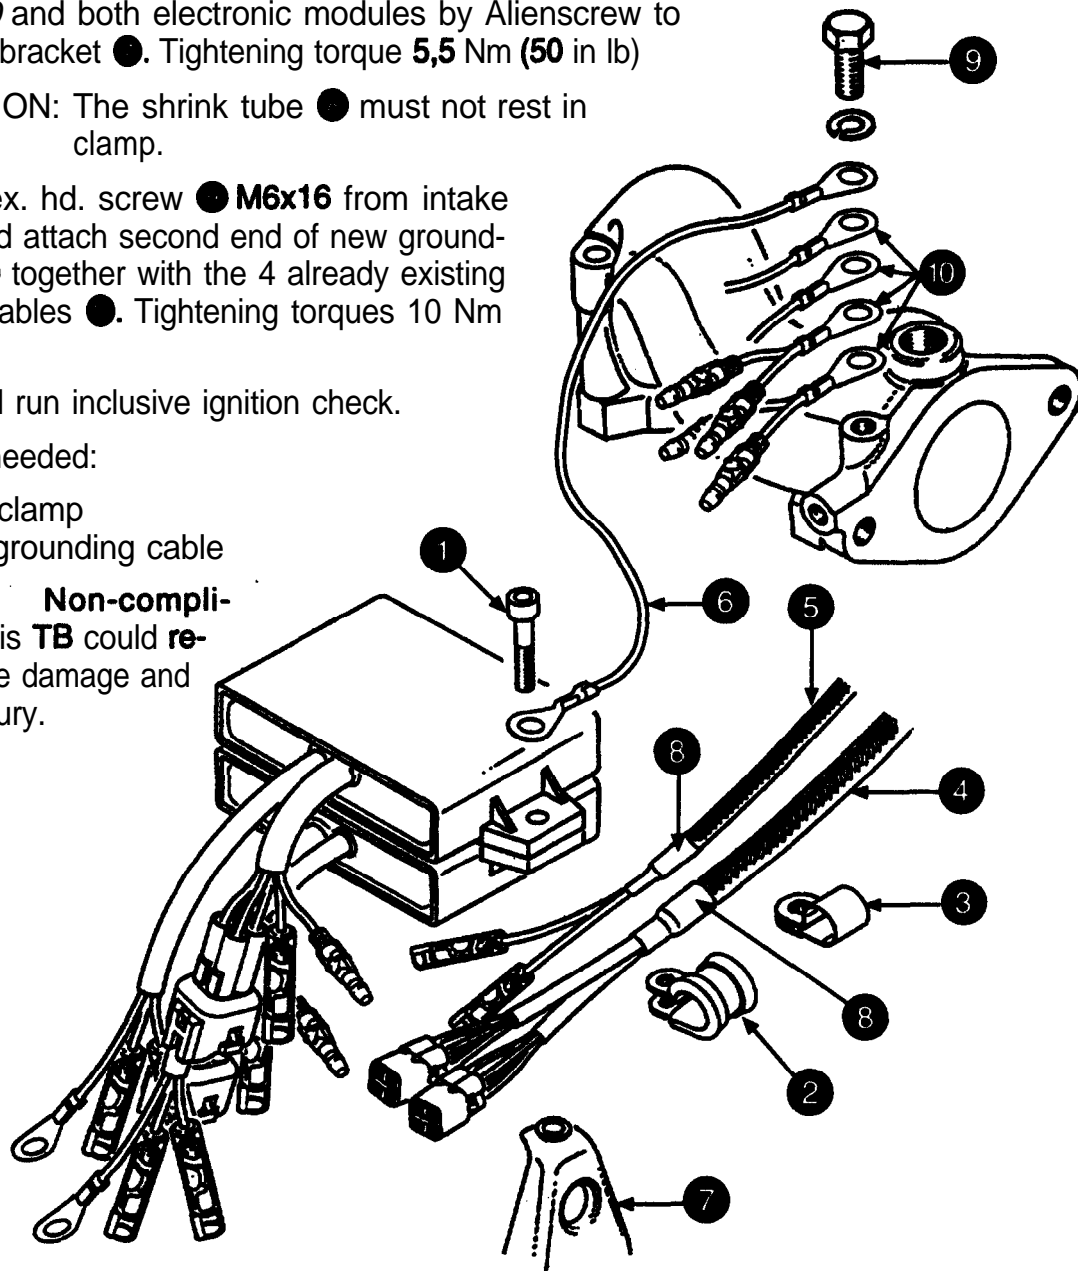
Instruction for rework

- Reason:** On the current installation of the ignition unit, troubles could **occur** in areas with heavy radio transmission. Because of the good **result** of the respective tests for EMC (electro magnetic **compatibility**) all the engines affected have to be reworked.

■ **ATTENTION:** The shrink tube ● must not rest in clamp.

- 1) Remove Allen screw ● **M5x25** and the clamp ● with **rubberlined** inside.
- 2) Slide new clamp ● (without rubberlining) over the cable-assemblies ● and ● so far that the screening braid rests completely in the clamp.
- 3) The **shorting** cables have to be furnished with screening over the complete length. The **screening** to be attached via short connection prices on the Alien screw ● together with grounding cable ●. On the ignition switch side the screening of the shorting cable has to be securely connected to ground too.
- 4) Attach new grounding cable ● *part-no. 965 787*, damp ● *part-no. 8511 79* and both electronic modules by Alienscrew to ignition coil bracket ●. Tightening torque **5,5 Nm (50 in lb)**

- 5) Remove hex. hd. screw ● **M6x16** from intake manifold and attach second end of new grounding cable ● together with the 4 already existing grounding cables ●. Tightening torques **10 Nm (90 in lb)**

- 6) Perform trial run inclusive ignition check.

1x 851 119 clamp
 1x 965 787 grounding cable
