No. 912-08

Electronic module with at Filter ROTAX Engine Series 1912.

Exchange of both SMD electronic modules, part-no. 965 356. Subject:

AIRWORTHINESS DIRECTIVE

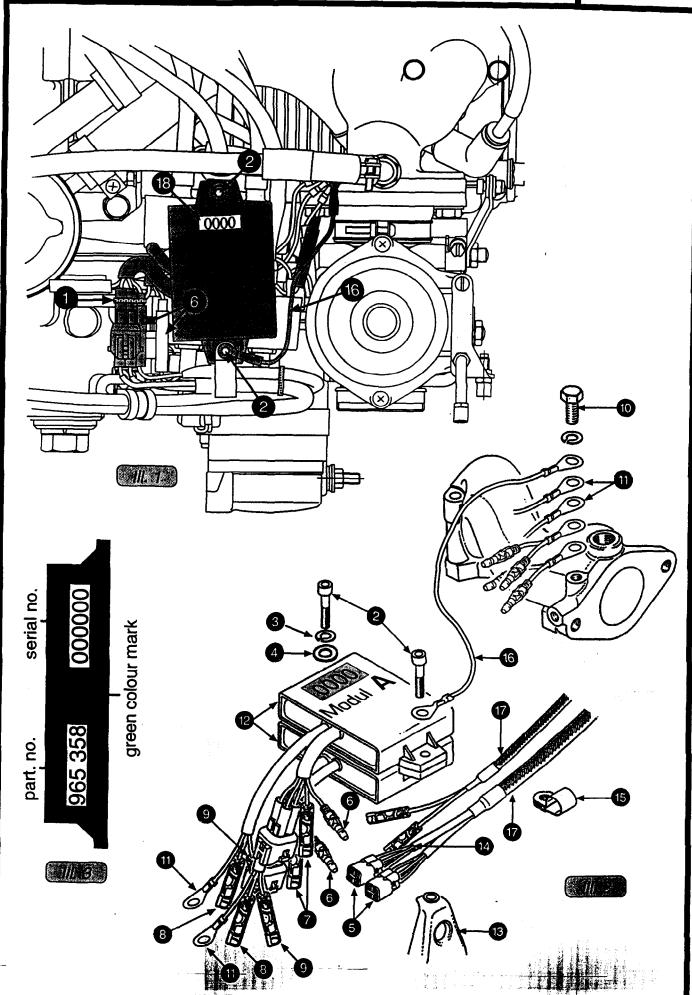
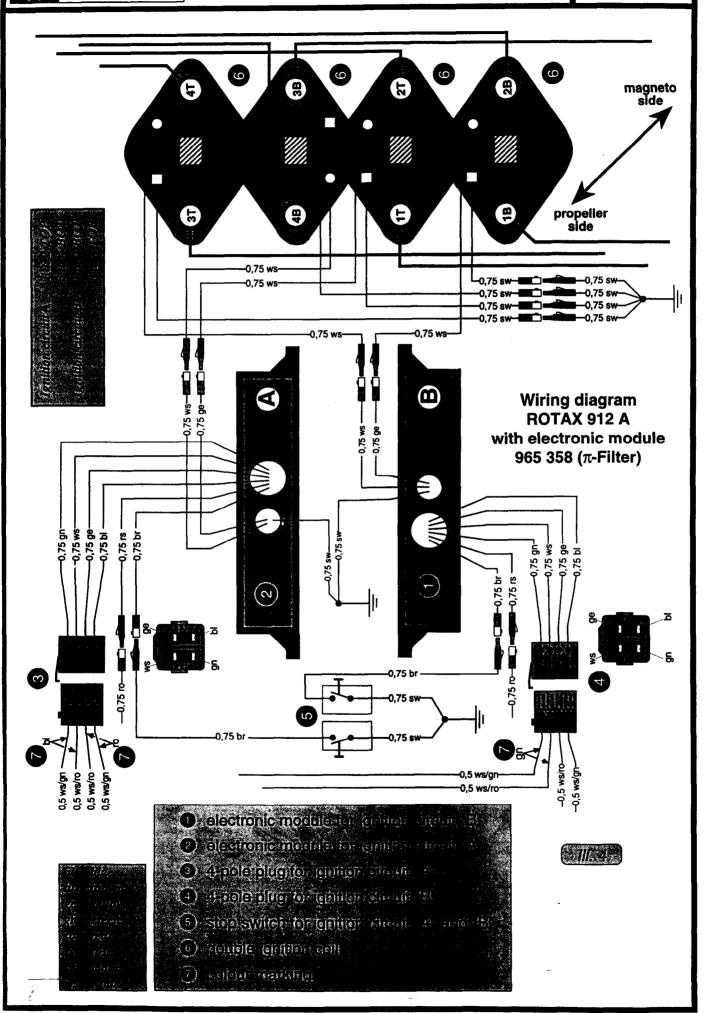
Consult also Illustration 1, 2, 3 and 4 an page 3 and 4.

- 1) Disconnect minus terminal of aircraft battery.
- 2) Cut snap tie 1 of plug receptacle. Remove both Allen screws 2 M5x25 along with lock washer 3 and washer 1. Mark and unplug both 4-pole plug connections 5 of pick-up lines, the plug connection of the red charging lines 3 and the plug connection of the brown stop lines 7 Mark and unplug the plug connections of the yellow 3 and white line 9, of the threefold cable cord leading to the ignition coils. By removing hex. hd. screw 10 detach the grounding cables 11 (one each per electronic module). Both electronic modules can be taken off now.
- 3) Connect the new type of electronic modules part-no. ② . 965 358 in reversed sequence according to the marking or as shown on the wiring diagram (III. 4) and place the two electronic modules back to back on ignition coil bracket ③.
 - ◆ NOTE:

The two modules are identical and are marked on the front side with a serial and part number. The 4-pole plug for ignition circuit "A", marked blue and red on end of insulation hose shall be connected to the top module.

Attach electronic modules along with both cable assemblies, cable clamps and grounding cable with Allen screw M5x25. Attachment on the other side by Allen screw M5x25 and lock washer and washer .

■ ATTENTION: The metal braid over the two cable assemblies has to rest completely in the cable clamp .

For traction relief secure again both 4-pole plugs with snap tie ①. Attach all 5 grounding cables with the hex.hd. screw ② M6x16 and lock washer on intake manifold.
