SERVICE INSTRUCTION AMENDMENT ON REDUCTION GEARBOX TYPE "C" AND TYPE "E" FOR ROTAX 2-STROKE UL AIRCRAFT ENGINES SI-06-1998

Amendment on reduction gearbox type "C" and type "E" for 2-stroke UL aircraft engines.

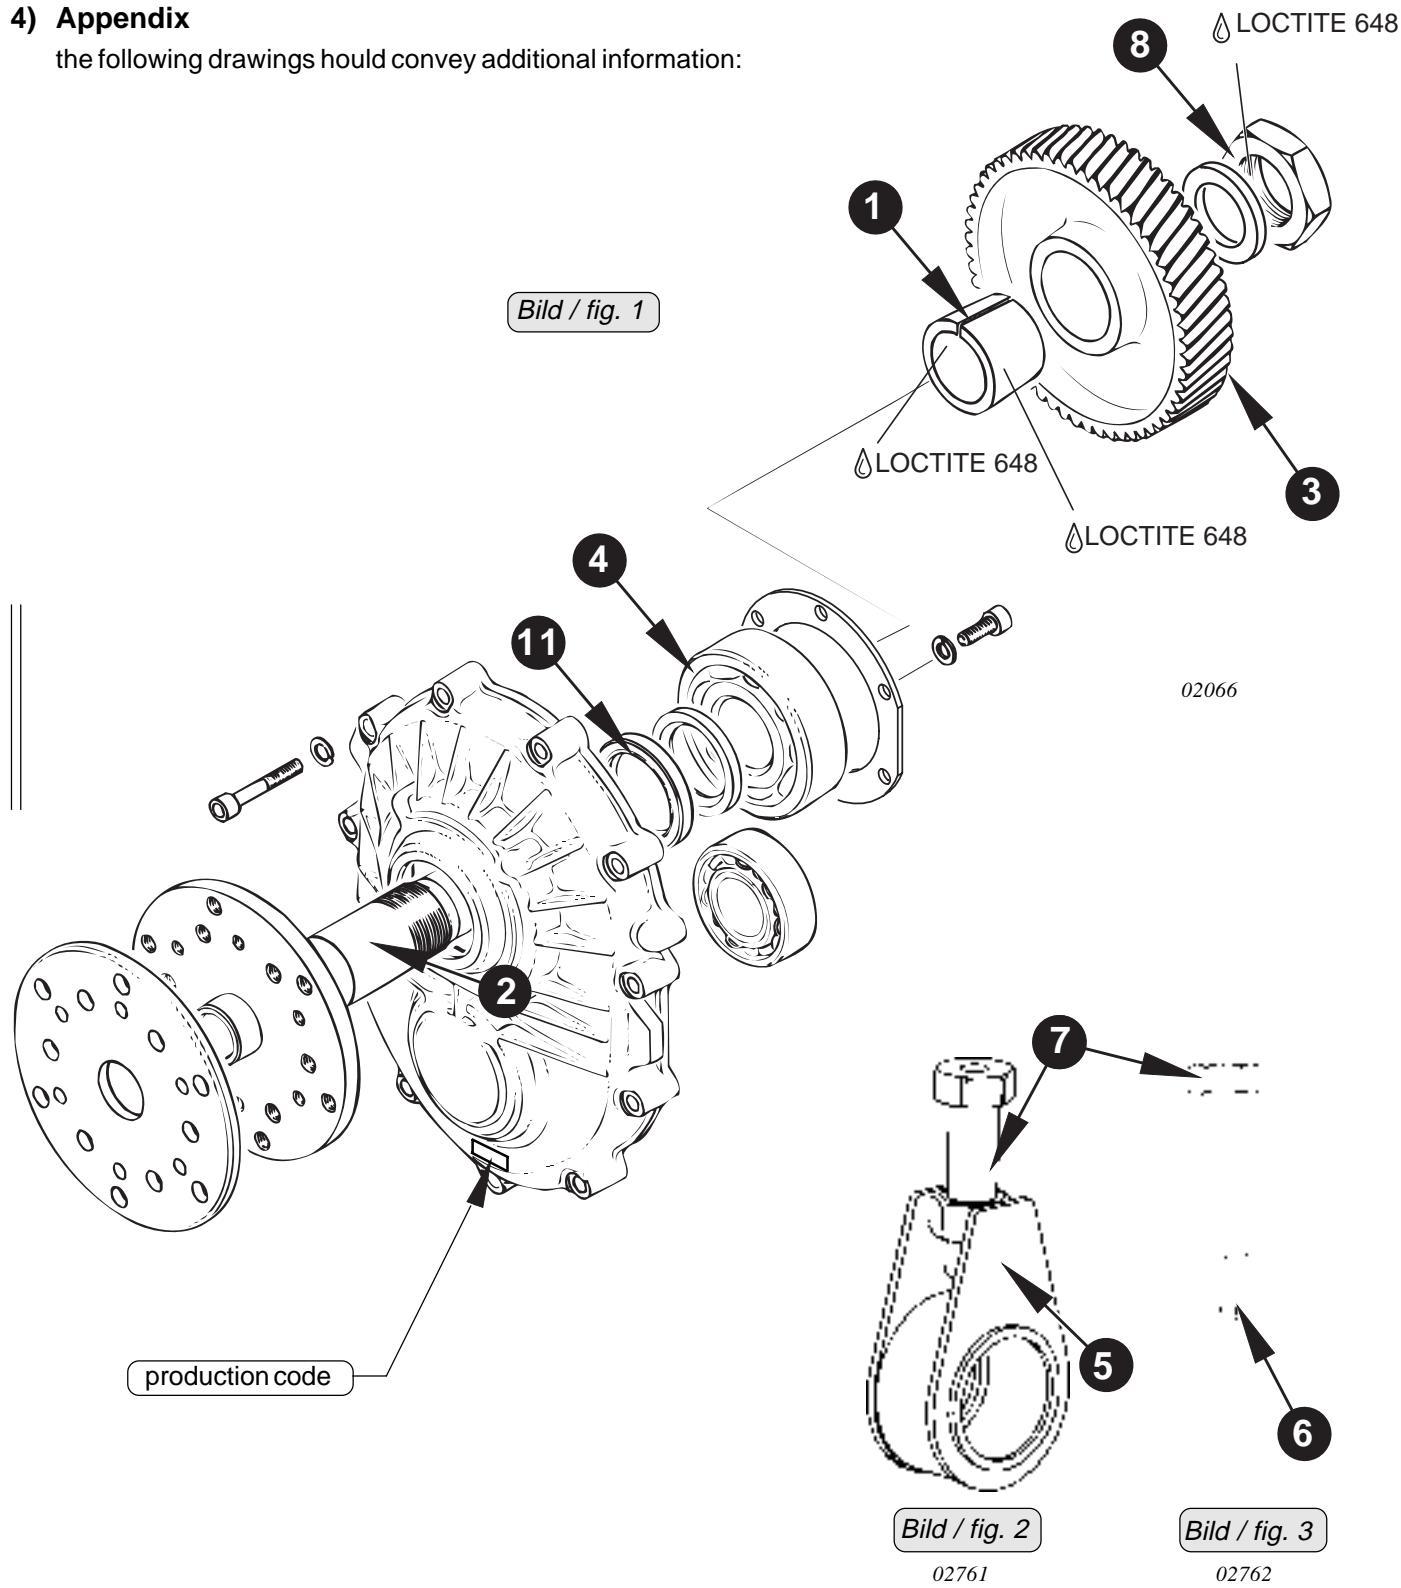
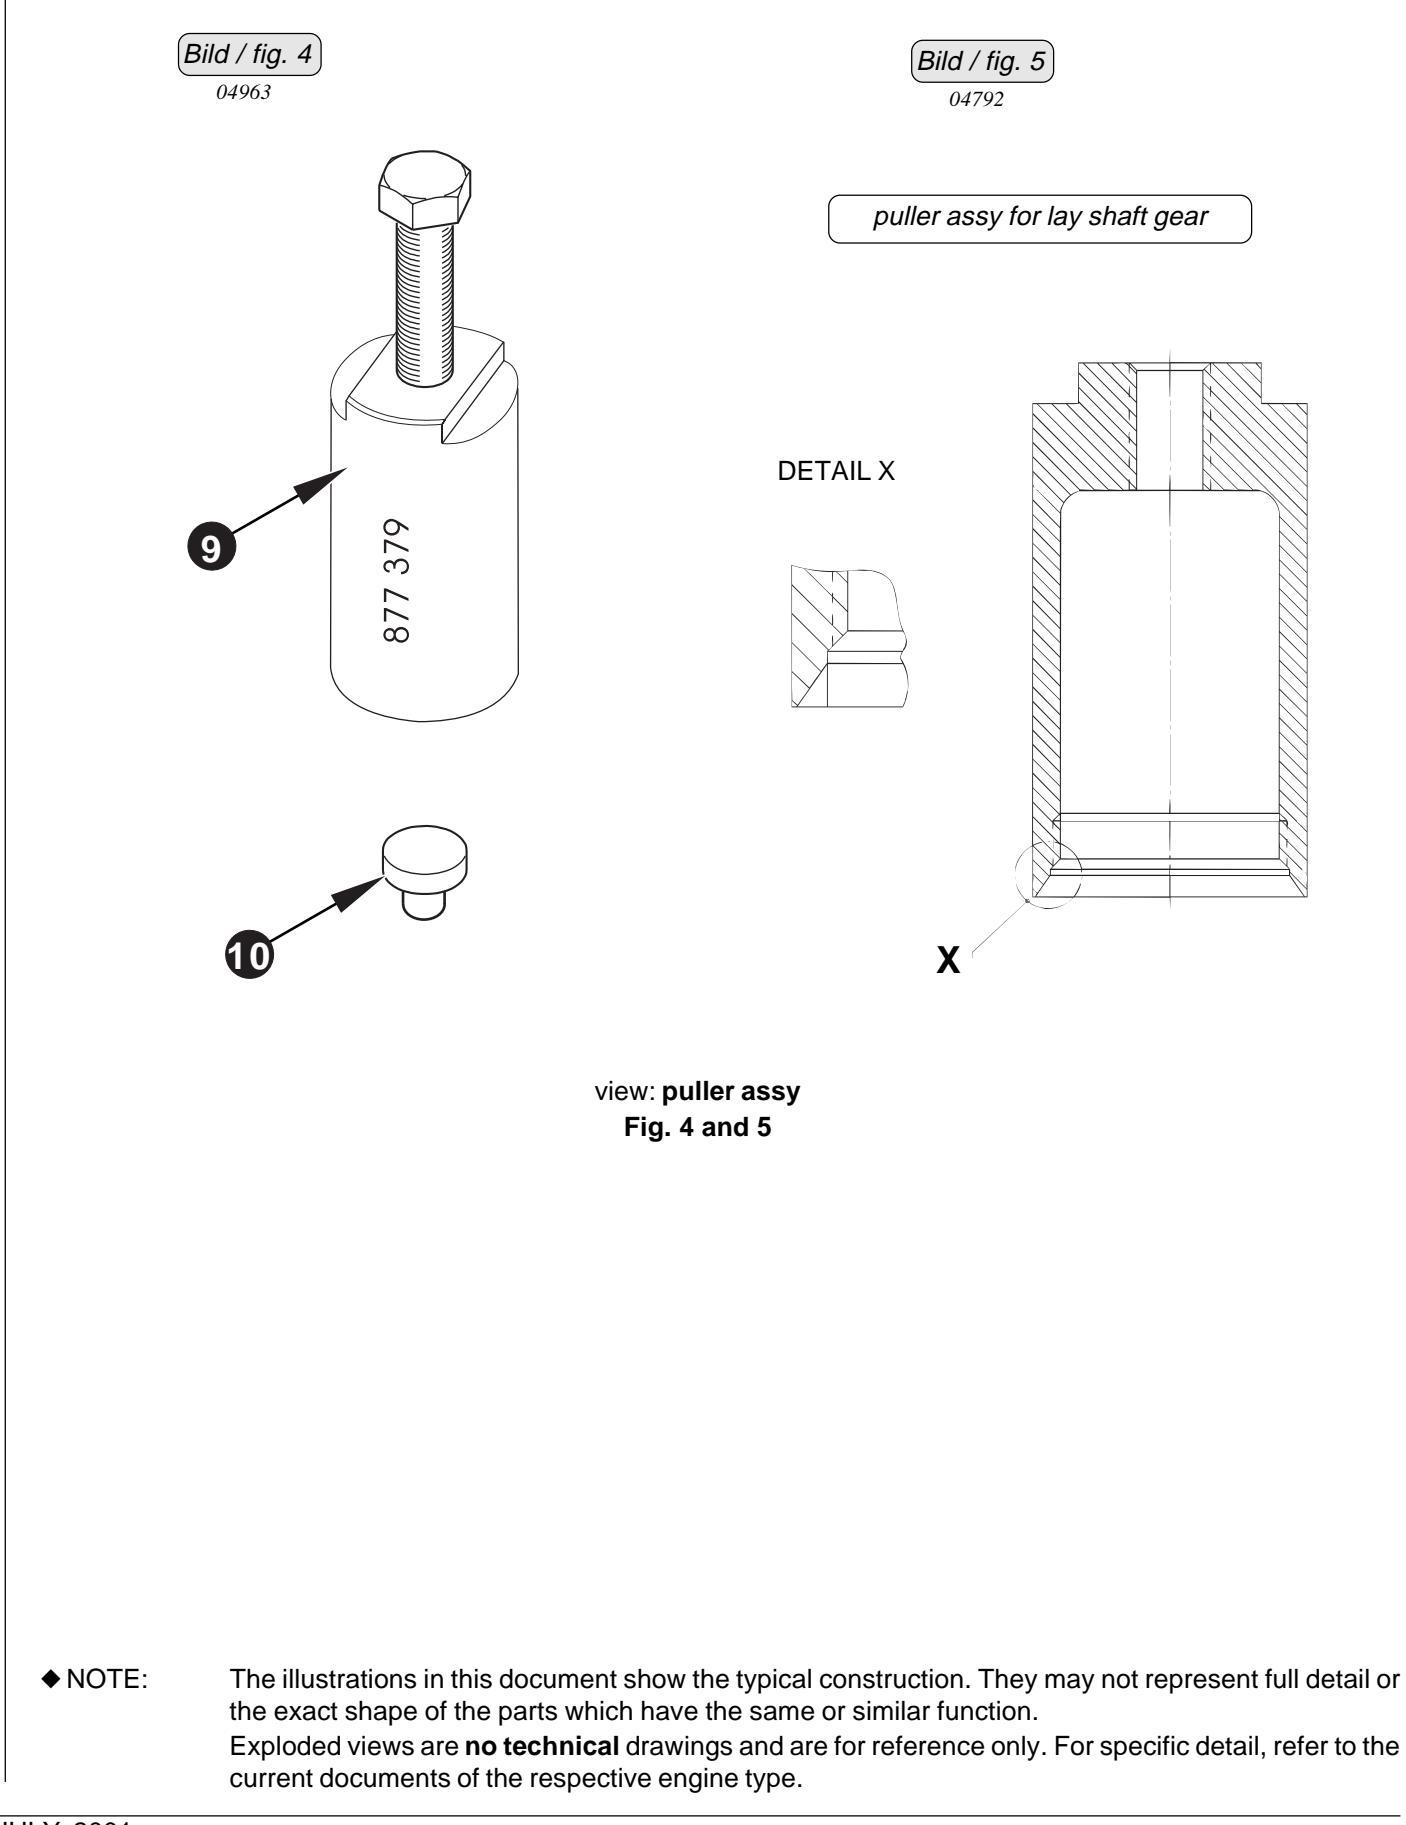
view: installation sleeve assy / C-gearbox Fig. 1, 2 and 3

Gluing-in of the cone sleeve will reduce the tightening torque of the hex. nut.

Introduction of an installation sleeve to facilitate fitting of the cone sleeve.

- Place cone sleeve (1) into installation sleeve assy (5). Make sure that the rotating shaft (6) of the pressure screw (7) comes to rest in the slot of the cone sleeve (1).

- Using a spanner move shaft (6) into slot until the cone sleeve (1) expands enough.
- CAUTION: But ensure that the shaft will not move beyond inside dia. of the sleeve. Otherwise you risk damage to the propeller shaft.

- Apply LOCTITE 648 on inside of cone sleeve (1).
- ▲ WARNING: Make absolutely sure that no LOCTITE will enter into the ball bearing (4).
- After placing cone sleeve (1) into position on propeller shaft slacken the pressure screw (7) and remove the tool.

- Apply LOCTITE 648 on outside of cone sleeve (1).
- The tightening torque of the hex. nut (8) has been newly specified to 250 ±10 Nm (185 ±7 ft.lb).
- Reassemble reduction gearbox in accordance with the current Repair Manual for engine type 462-532-582.

- ■CAUTION: Allow at least 12 h for curing of the adhesive.
