## ALERT SERVICE BULLETIN

# CHECKING OF THE OIL PUMP FIXING BOLTS FOR CORRECT TORQUE FOR ROTAX® ENGINE TYPE 912 AND 914 (SERIES) ASB-912-060UL ASB-914-043UL

## CHECKING OF THE OIL PUMP FIXING BOLTS FOR CORRECT TORQUE FOR ROTAX<sub>®</sub> ENGINE TYPE 912 AND 914 (SERIES) ASB-912-060

Checking of the oil pump fixing bolts for correct torque for ROTAX engine type 912 and 914 (Series).

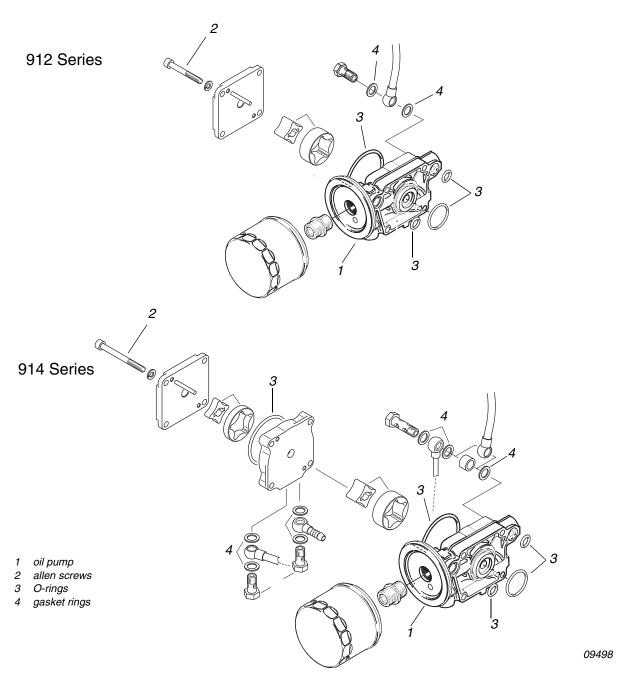
Fig. 1
Oil pump 912/914 Series

Within the scope of permanent quality checks we have identified a deviation in the assembly process of the oil pump fixing bolts. In some cases these bolts were not tightened according to the proper torque specification which can possibly cause oil leaks, irregular oil supply which may lead to engine stoppage.

- CAUTION: The following steps are important, read carefully!
- 1. Perform inspection for oil leaks in the area of the oil pump. See fig. 1.
- 2. If you notice oil leaks then all following tasks have to be performed from section 3.1.1 to 3.3 inclusive.
- 3. If you notice no oil leaks then only the section 3.1.1 need to be performed.
- ◆ NOTE: The torque control must be performed on all affected engines, regardless of any oil leaks.

- ◆ NOTE: Tighten allen screws in a crosswise sequence!
- 1. Check and/or tighten the 4 oil pump (1) allen screws (2) with lock washer to 10 Nm (90 in.lb.).

- 1. Remove the oil pump in accordance with the relevant Maintenance Manual (Heavy).
- 2. Inspect the surfaces for wear, cracks or damages.
- 3. Replace all O-rings (3) and gasket rings (4). Spare and replacement parts should be ordered using the current Illustrated Parts Catalog.
- 4. Install the oil pump in accordance with the relevant Maintenance Manual (Heavy).

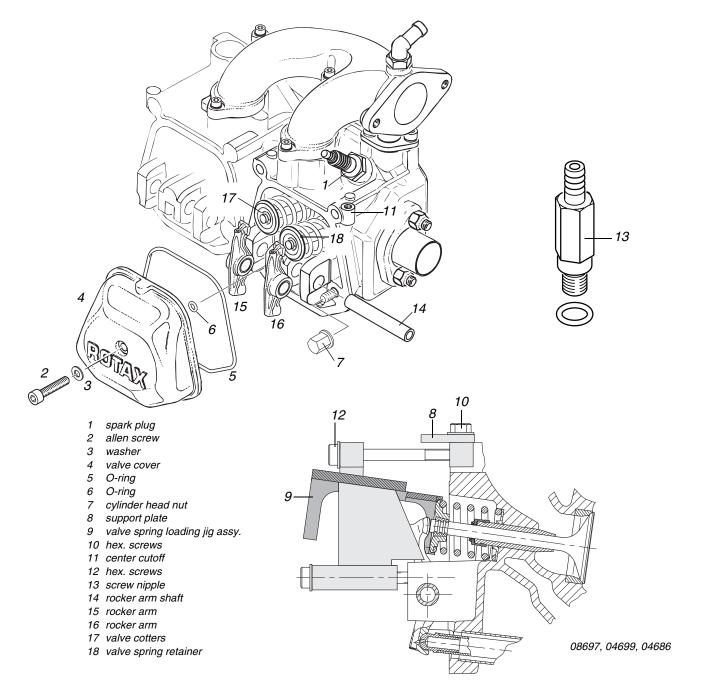
Fig. 2 valve train

See fig. 2.

The following steps are necessary to rule out a pre-damage of the valve train:

- 1. Remove the spark plug connector and the 4 top spark plugs (1).
- CAUTION: Prevent entering of foreign matter through spark plug hole.
- 2. Remove Allen screw (2) M6x30 with washer (3) from valve cover (4).
- 3. Remove large and small O-ring (5) and (6).
- 4. Tap valve spring retainers slightly with a soft mallet to loosen valve spring retainers from the valve cotters.
- 5. Turn crankshaft so that the respective piston is exactly on ignition top dead centre (compression stroke).
- 6. Remove the external cap nut (7) (exhaust side of cylinder).

- 7. Attach the support plate (8) for the valve spring loading jig (9) with 2 hex. screws (10) M6x16 at the attachment points (11) on the cylinders.
- Attach the valve spring loading jig on cylinder head and support plate with 2 Allen screws (12) M6x70.

- 12. Depress the 2 valve spring evenly by the valve spring loading jig (9) until the valve cotters are easily accessible. Simultaneously both hydraulic tappets will be relieved.

- 13. Remove rocker arm shaft (14).
- CAUTION: At removal take care not to damage the rocker arm shaft bearings in the cylinder head.
- 14. Remove both rocker arms (15) and (16).

- 15. Remove the valve cotters (17).
- ♦ NOTE: To facilitate the removal of valve cotters use grease or magnet.
- 16. Remove the valve spring loading jig (9).

- 17. Remove the valve spring retainers (18).
- 18. Remove the inlet- and outlet valve springs.
- 19. Remove the washers.
- 20. Check the washers for increased wear.

See fig. 2.

- ◆ NOTE: To facilitate installation apply a bit of grease so that the valve spring retainer (18) will remain on the valve spring.
- 1. Insert the washers.

- 4. Depress the 2 valve springs evenly by screwing in the 2 Allen screws (12) until the valve cotters can be inserted.
- ♦ NOTE: If the valve spring loading jig (9) does not press down the valve spring retainer correctly it could touch the valve system, possibly resulting in pressure loss in the cylinder.

- 10. Place inlet rocker arm (15) and outlet rocker arm (16) into position, apply MOLYKOTE G-N on both ends of rocker arm shaft (14) and insert it into its bore in cylinder head.

- 15. Clean the sealing surface of cylinder head and valve cover.
- 16. Insert new O-ring (5) 105x2,5 and O-ring (6) 6,4x1,8 into the valve cover (4).
- 17. Fit valve cover.

- ♦ NOTE: Between the 2 valve covers a gap of min. 0,2 (.008 in.) must remain. The covers must not touch each other.
- 18. Tighten the new Allen screw (2) M6x30 with washer (3) to 10 Nm (90 in.lb.).
