Special inspection to increase the TBO for engine type 912 UL

Increase of TBO from 600^h/10 years to 1200^h/15 years.

Generally all engines of Series Type 912 UL up to and including engine No. 4,152.666 From engine N. 4,152.667 onwards the 1200^h TBO is covered by SI 26 UL-94.

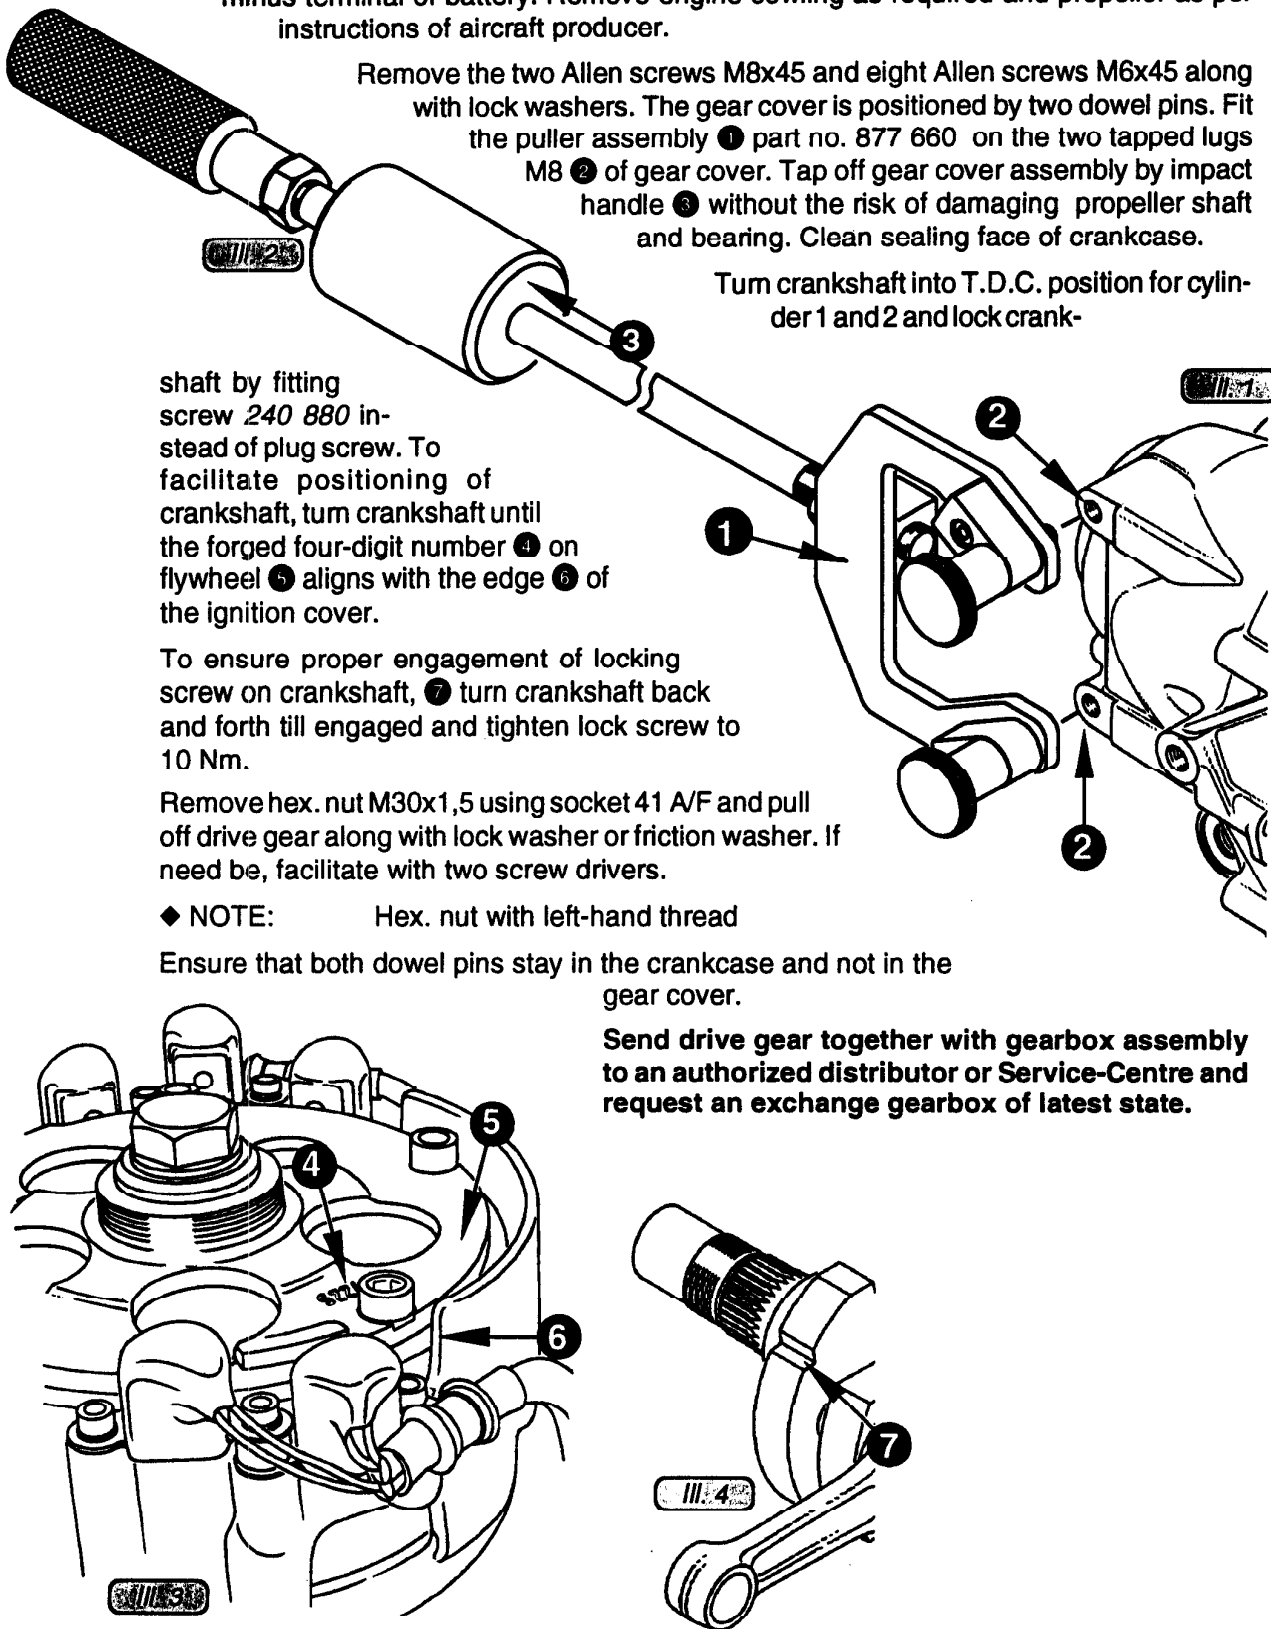
Remove the two Allen screws M8x45 and eight Allen screws M6x45 along with lock washers. The gear cover is positioned by two dowel pins. Fit the puller assembly ① part no. 877 660 on the two tapped lugs M8 ② of gear cover. Tap off gear cover assembly by impact handle ③ without the risk of damaging propeller shaft and bearing. Clean sealing face of crankcase.

shaft by fitting screw 240 880 instead of plug screw. To facilitate positioning of crankshaft, turn crankshaft until the forged four-digit number ④ on flywheel ⑤ aligns with the edge ⑥ of the ignition cover.

To ensure proper engagement of locking screw on crankshaft, ⑦ turn crankshaft back and forth till engaged and tighten lock screw to 10 Nm.

Remove hex. nut M30x1,5 using socket 41 A/F and pull off drive gear along with lock washer or friction washer. If need be, facilitate with two screw drivers.

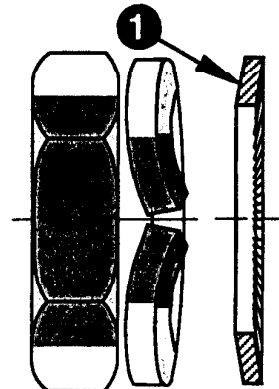
III. 5

If hex. nut is still secured by a lock washer, it has to be exchanged for the friction washer ①. Slide drive gear of the exchange gearbox on cleaned serration of crankshaft and fit friction washer and hex. nut M30x1,5.

■ ATTENTION: Secure hex. nut with LOCTITE 221. Hex. nut with L.H. thread.

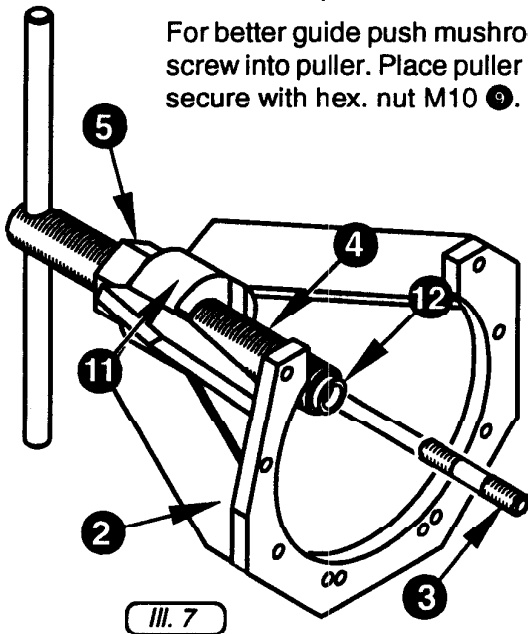
III. 7

Remove circlip ① using a pair of circlip pliers. Attach puller structure ② 877 615 with 8 Allen screws M6x25 on crankcase. Fit stud ③ M10x45/20 into puller screw ④ 877 580 and hex. nut ⑤ M24x1,5 on puller screw.

For better guide push mushroom insert ⑥ 877 592 into roller bearing ⑦ and place puller screw into puller. Place puller plate ⑧ 877 560 from backside of crankcase onto stud and secure with hex. nut M10 ⑨.

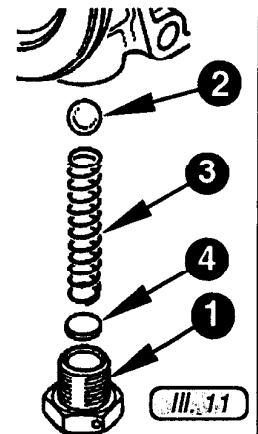
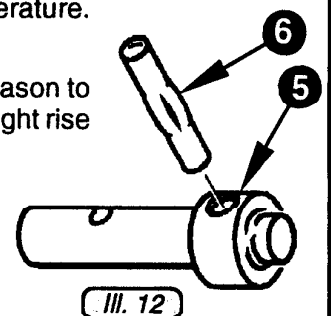
Remove plug screw ❶ of pressure relief valve ❷, clean valve and check ball seat in housing. Clear all oil passages by compressed air. From engine serial no. 4,005.186 onwards, to improve oil pressure control the following parameters of the relief valve were changed. Free length of the compression spring ❸ was reduced from 46 mm to 39,5 mm. Spring rate was changed by increase of wire dia. from 0,8 mm to 0,9 mm, and dia. of ball was increased from 8 mm to 8,5 mm.

If existing, remove shim ❹, but if specified oil pressure can't be reached, adjust pressure by adding shim again.

From engine serial no. 4,152.101 onward the follower in the oil pump shaft ❺ was changed to notched pin ❻ instead of the former dowel tube.

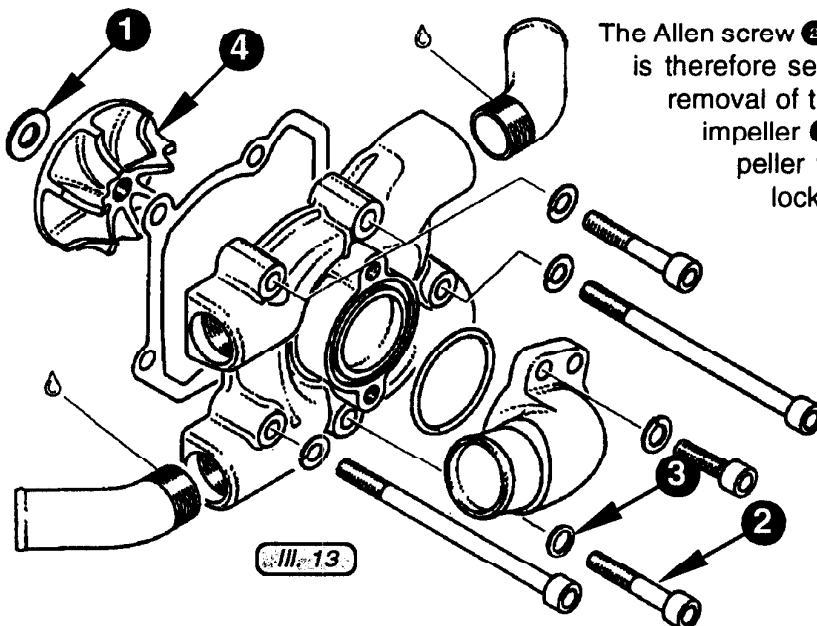
At engine operation without antifreeze in the coolant, increased formation of corrosion takes place. Therefore the material of the pump shaft was changed with engine serial no. 4,152.414. Because of galvanic reactions, caused by the use of various materials, the washer Q and the screw W are of stainless steel since engine serial no. 4,152.607.

The Allen screw ② extends into the waterspace and is therefore sealed by the ring gasket ③. After removal of the water pump housing, unscrew impeller ④ anticlockwise by use of the impeller wrench 877 295, with crankshaft locked.

Check water pump shaft at thread chamfer ⑤ for possibly existing corrosion. At bad corrosion renew water pump shaft. For this renewal remove ignition housing and fit new water pump shaft as per instructions in the Repair Manual.

◆ Note: The new shaft ends in a cone ⑥.

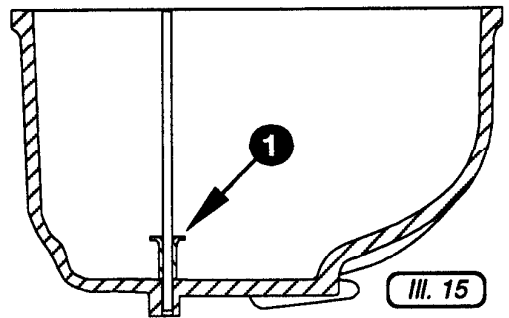
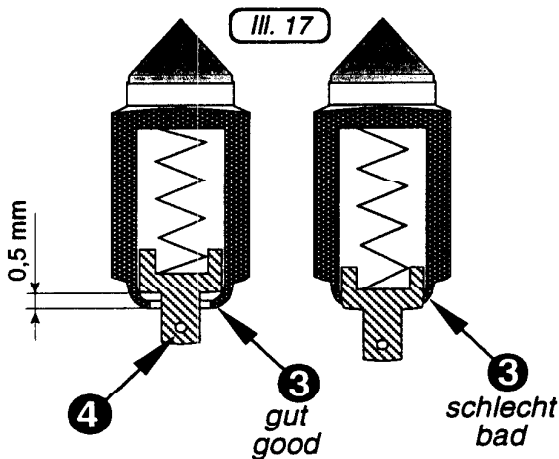
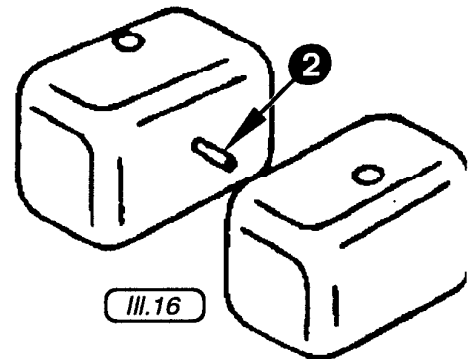
Remove float chamber and lift out both floats. If float chamber is still without distance pieces ① part no. 861 920, add them now, thus avoiding possible sticking of the floats in the float chamber.

Check support pin ② of floats. At heavy wear of float bracket contact faces, caused by excessive vibration, renew float and float bracket as required.

Examine float valve with float chamber removed. At noticeable wear of beaded edge ③ at the sprung pin ④ the valve has to be renewed. If the distance becomes less than 0,5 mm (see ill. 17) the float level will be effected too.
