**ROTAX****S E R V I C E I N F O R M A T I O N**

7 UL 97-D/E

Kalibrierung der Gemischanreicherndüse bei Rotax 914 UL (Serie)**Calibration of the mixture enrichment jet of ROTAX 914 UL (series)****Vorgeschrieben / mandatory****1) Wiederkehrende Symbole:**

Verification or calibration of the mixture enrichment jet.

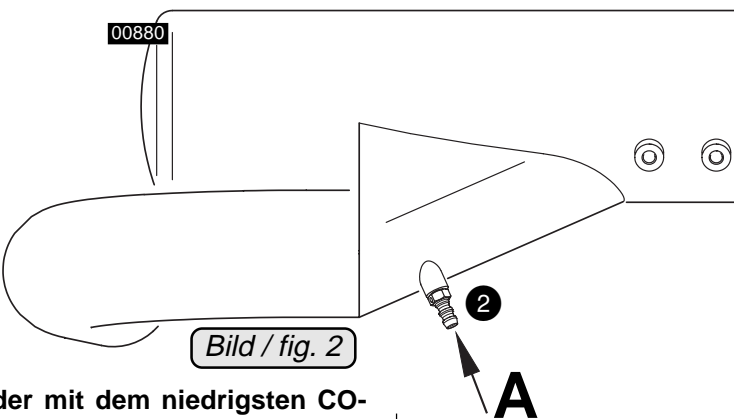
■ **ATTENTION:** The target value is within 4 % to 6 % CO on the cylinder with the lowest emission.

This CO-emission is valid only for take-off performance. On all other performance settings (boost pressure below 1250 hPa) lower CO-emission is permissible.
