SERVICE INSTRUCTION

Introduction of a new clamp part no. 638140 for ROTAX 912 i Series

ATA System: 76-00-00 Engine control

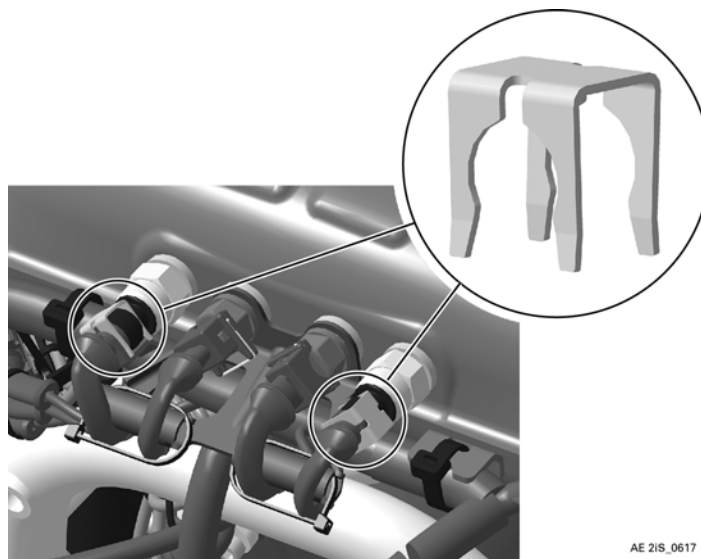
Fig. 1

POSITION OF THE CLAMP

Step	Procedure
1	Check connector of MAP sensors for tight fit. NOTE: Make sure the connector latch shows vertically to the bottom.
2	Install the clamp as shown in figure 1. Check for tight fit and correct position of the clamp on sensor and connector. NOTE: To remove the clamp use a proper pair of pliers.
